June 3, 2020

PROPERTY: LAS TORRES HOMEOWNERS ASSOCIATION  
CAREFREE, ARIZONA

SERVICE: FULL PROPERTY EVALUATION AND RESERVE FUND ANALYSIS

ATTACHMENT: 19-0228 FINAL REPORT – REVISION 1

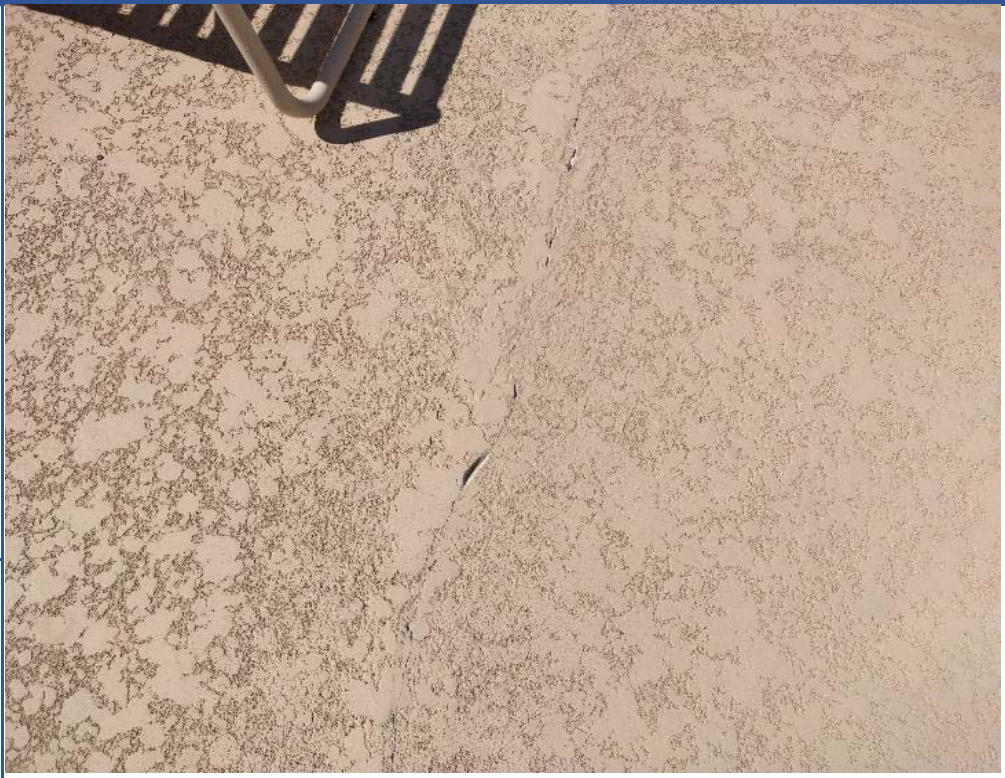
The surrounding acrylic pool deck appeared to be in generally good to fair condition with some cracking noted.

Cracking in the acrylic pool decking

- ✓ Acrylic Pool Deck - Resurface – Resurfacing of the acrylic pool decking. This wears over time and may need to be patched in small areas for aesthetic purposes or if it begins to present a tripping hazard. Typically these smaller repairs would fall under operations and maintenance.

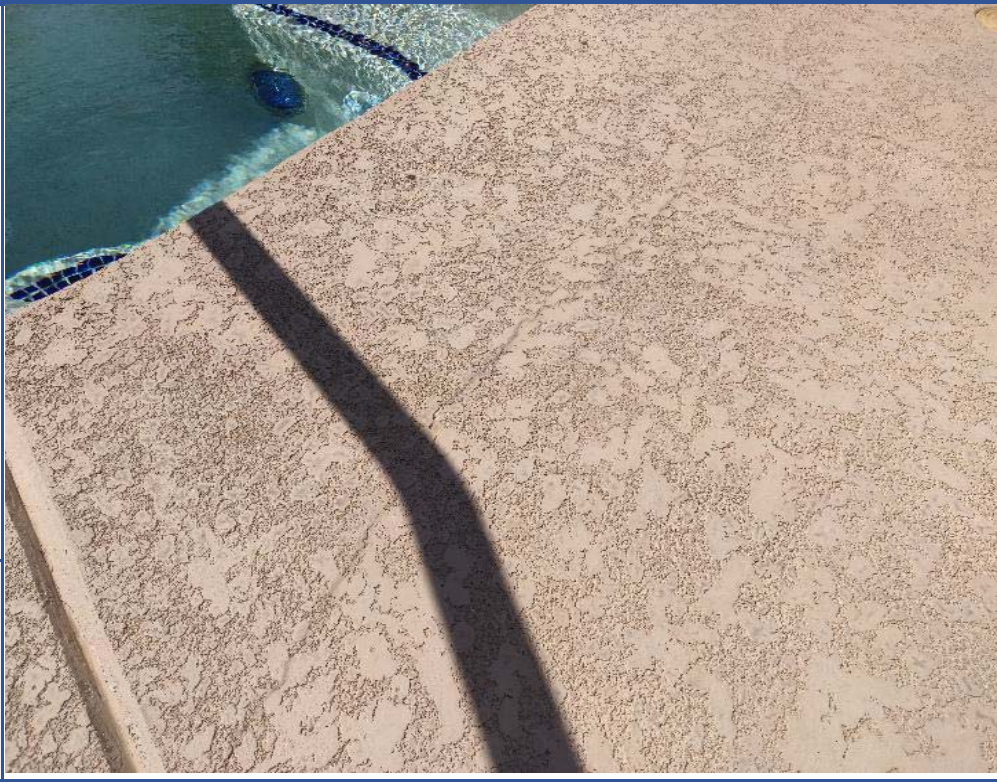
PHOTO NUMBER  
**6**

Cracking in the acrylic pool decking

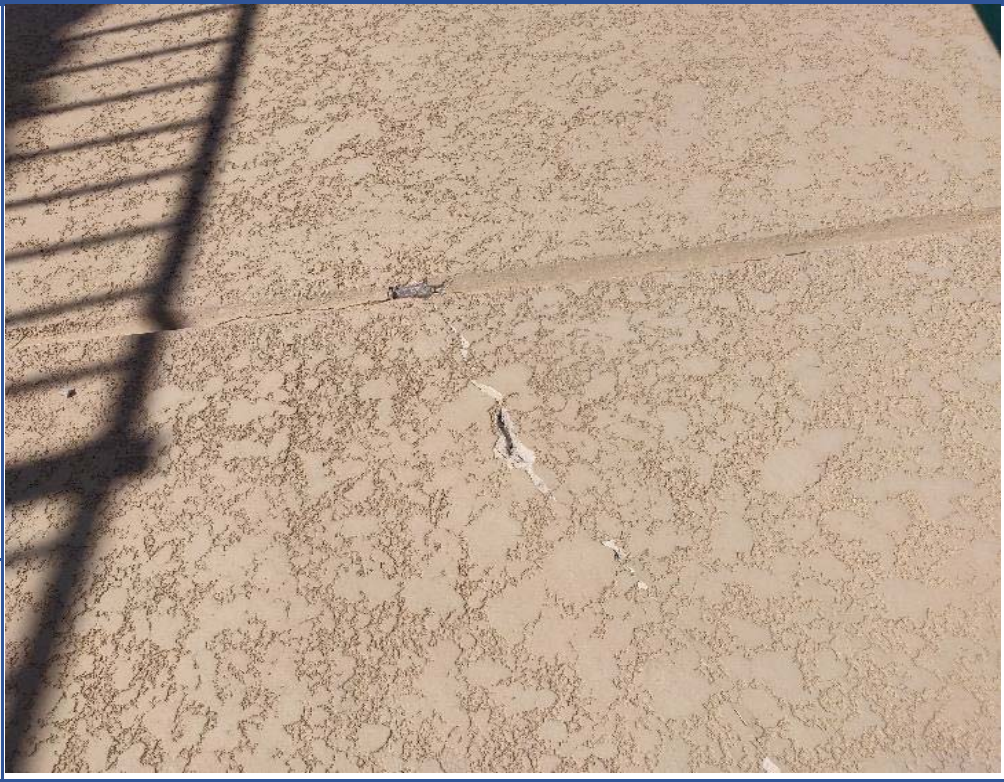
<p><b>Description:</b></p> <p>Cracking in the acrylic pool decking</p>
<p><b>11</b></p>

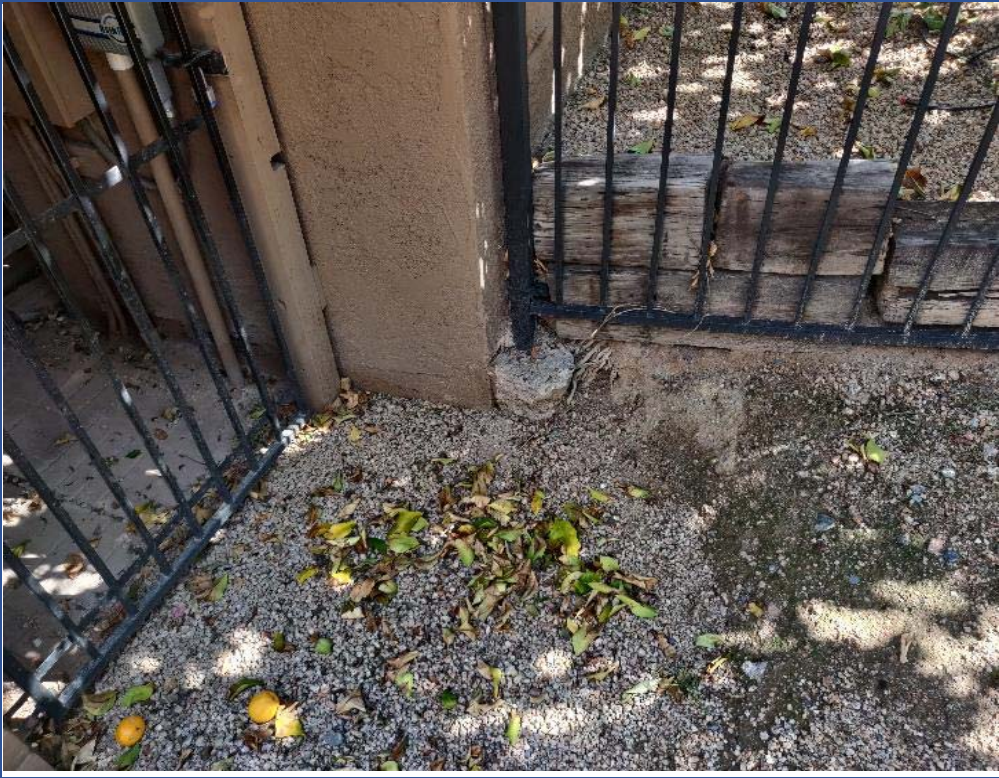
13

Exposed pool fence footing

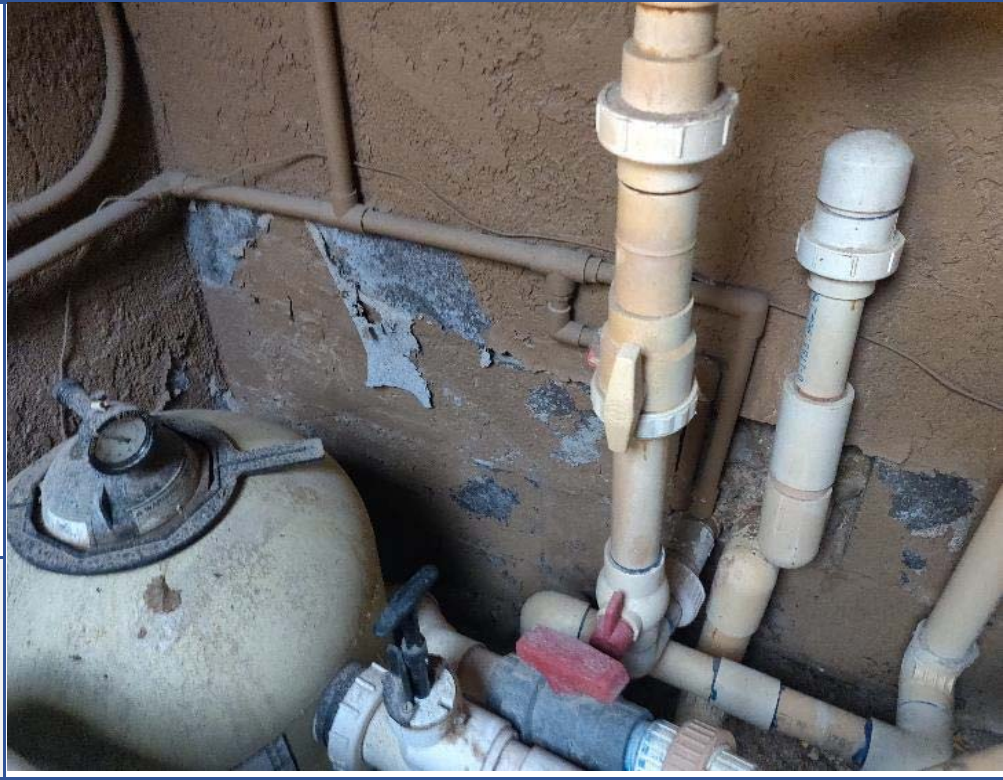
21

Paint spalling on the wall, below grade of pool deck

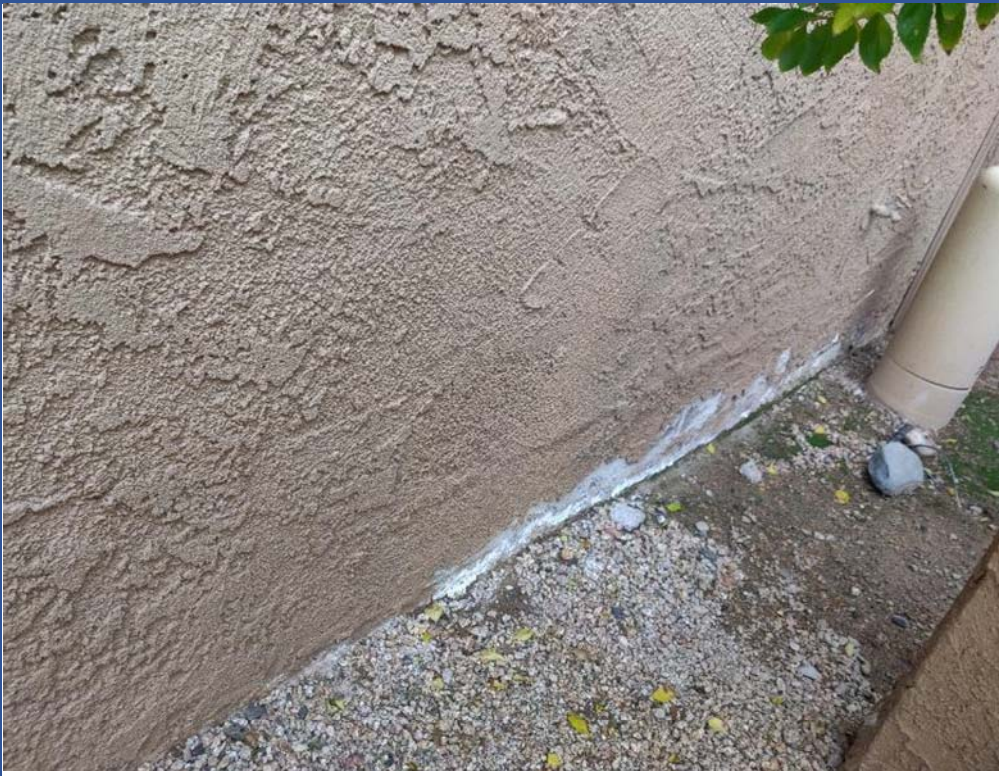
Paint spalling near the bottom of the wall

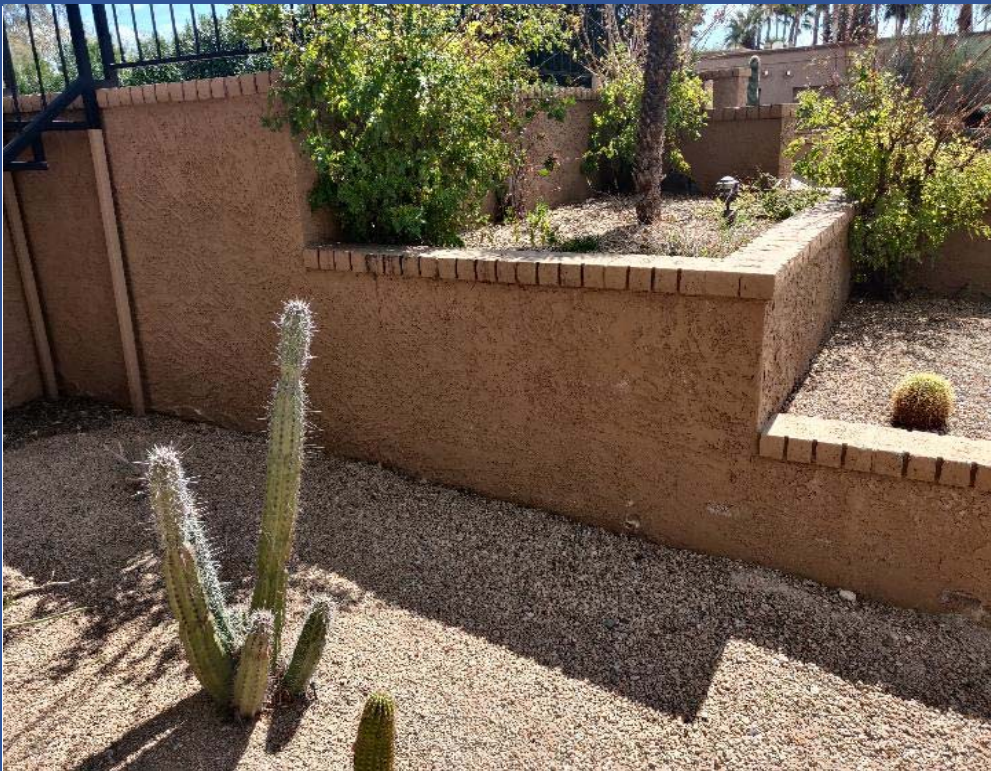
26

The retaining portions of the block walls did not appear to contain weep holes, at least none that were visible. Weep holes allow excess water to drain, which reduces the hydrostatic load on the wall and limits deterioration by reducing water damage that trapped water would otherwise cause. Given the assumption that the walls are of original construction, we would typically expect more visible and apparent issues than were observed.

As water makes its way through the wall and contacts the steel reinforcing within, the steel begins to corrode leading to a loss of structural integrity. It is common to see the wall eventually develop a pronounced lean in part due to the loss of strength and the increased load from trapped water. Another common occurrence is cracking of the block face when the steel reinforcing corrodes and expands, however, as the walls are covered in textured cementitious stucco this may not be as visible.

Retaining walls - no  
visible weep holes, some  
paint spalling

Our recommendation is to obtain further evaluation of the walls by a licensed professional structural engineer to determine the best course of action going forward.

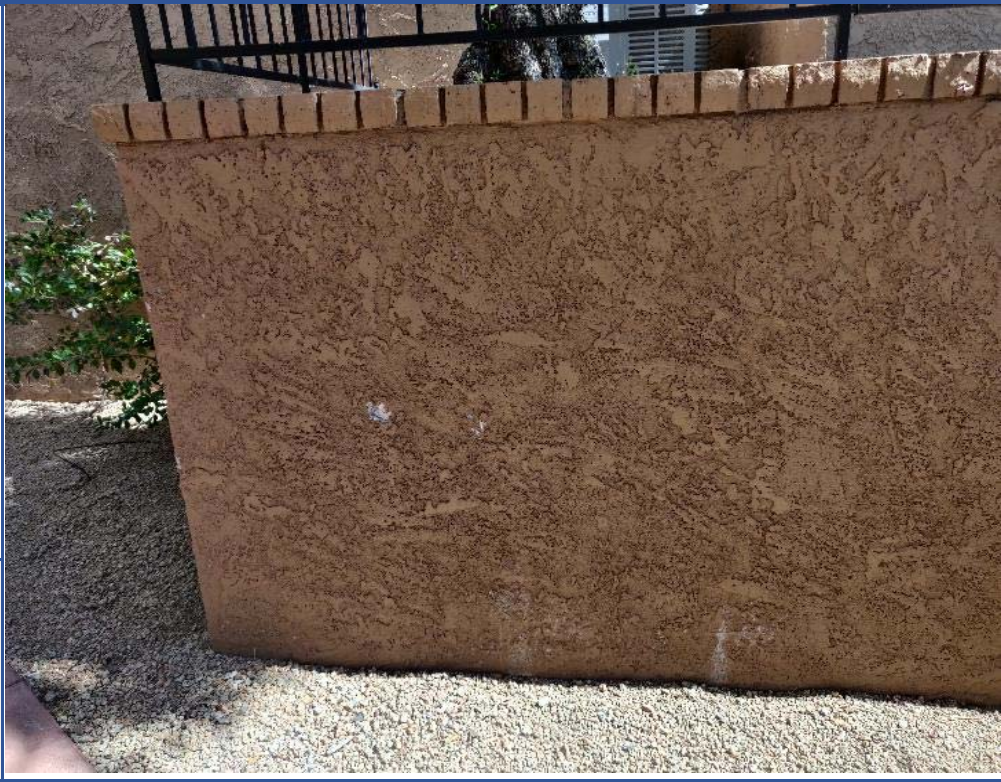
27

Visible efflorescence

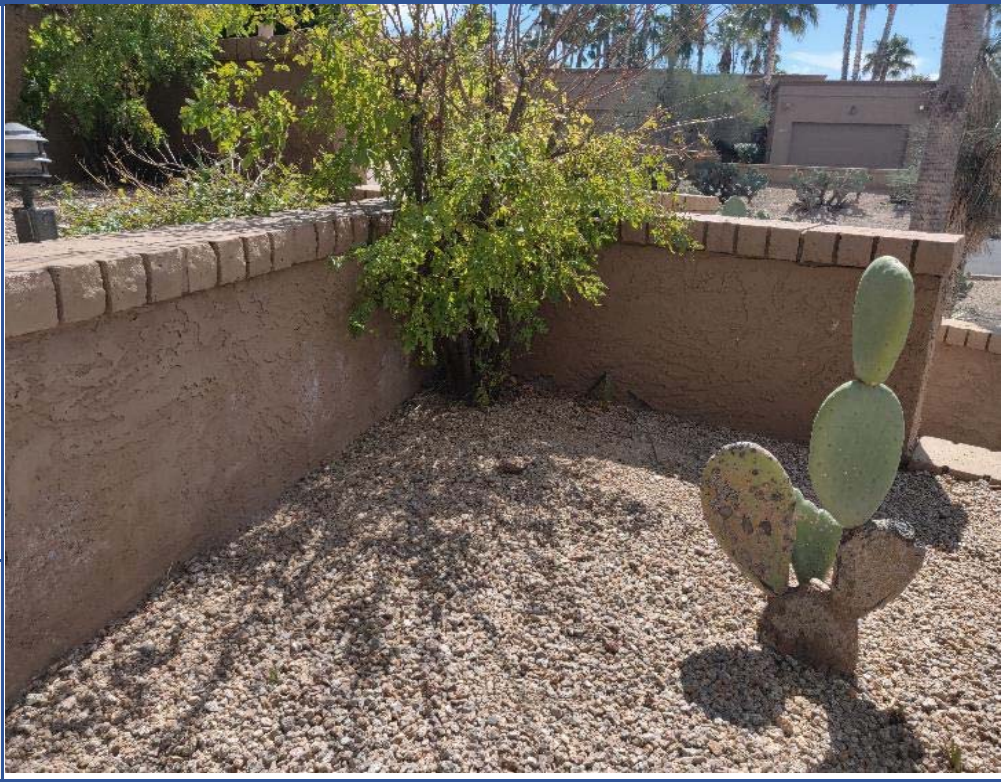
28

All foliage, plants and irrigation should be 3-feet from walls

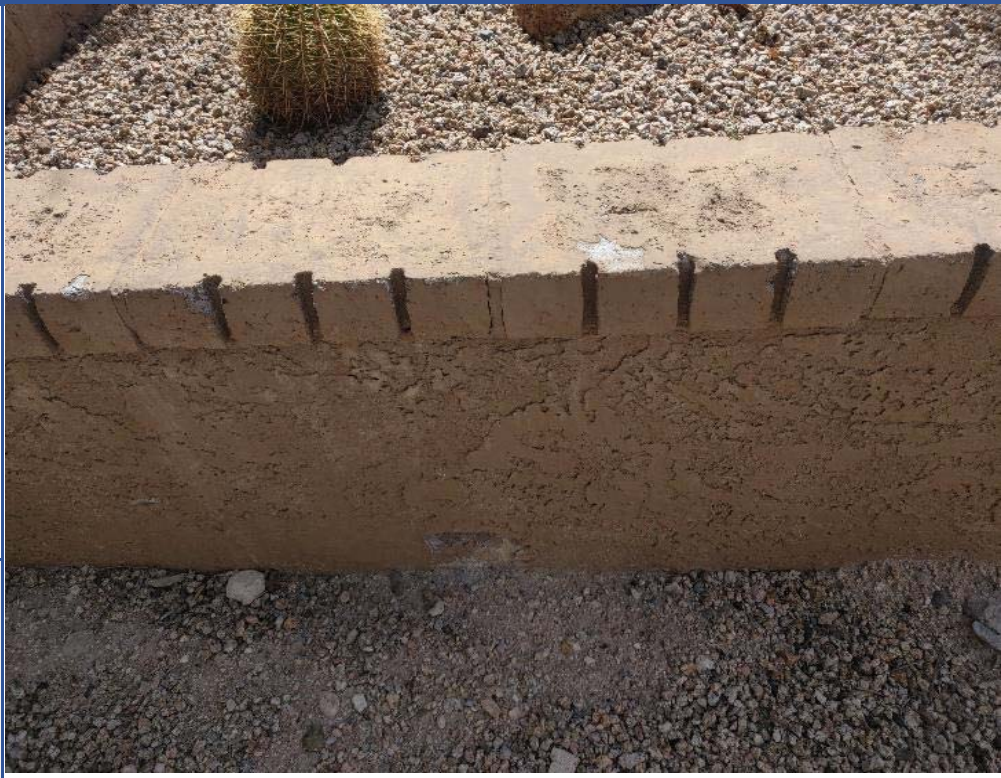
Spalling paint at lower courses of the wall

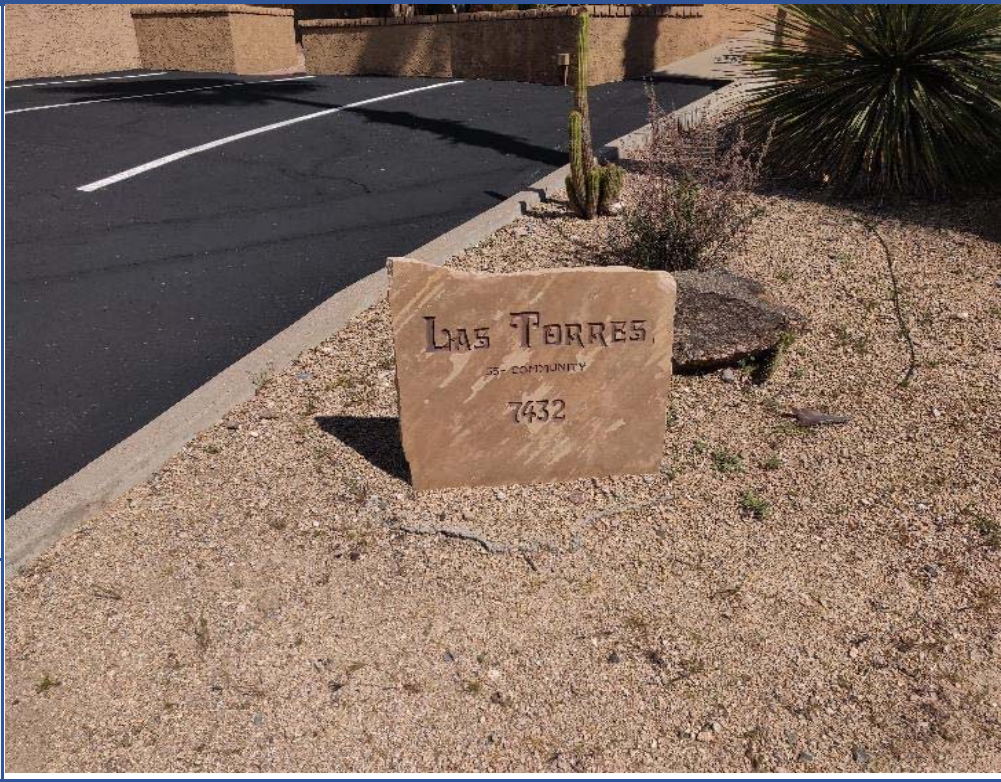
33

Community stone sign - footing exposed

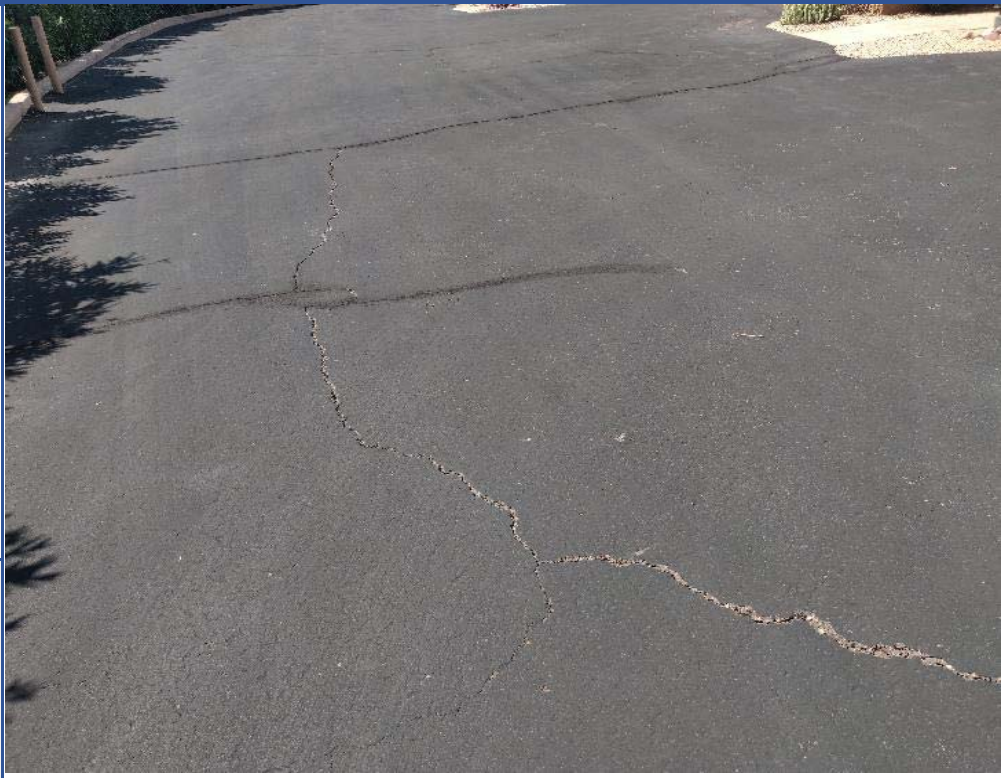
Further, it has been our experience that community associations seek to save budget by stretching out the periodic seal coat, which can result in premature deterioration. An appropriate schedule should be followed to extend the life of the asphalt.

Asphalt road cracking since last crack sealed and seal coated

- ✓ Asphalt - Crack Seal & Seal Coat – Budget to crack seal and seal coat the association responsible asphalt. There are several types of asphalt treatments and seal coats, the community should consult with an asphalt professional to determine the best choice.

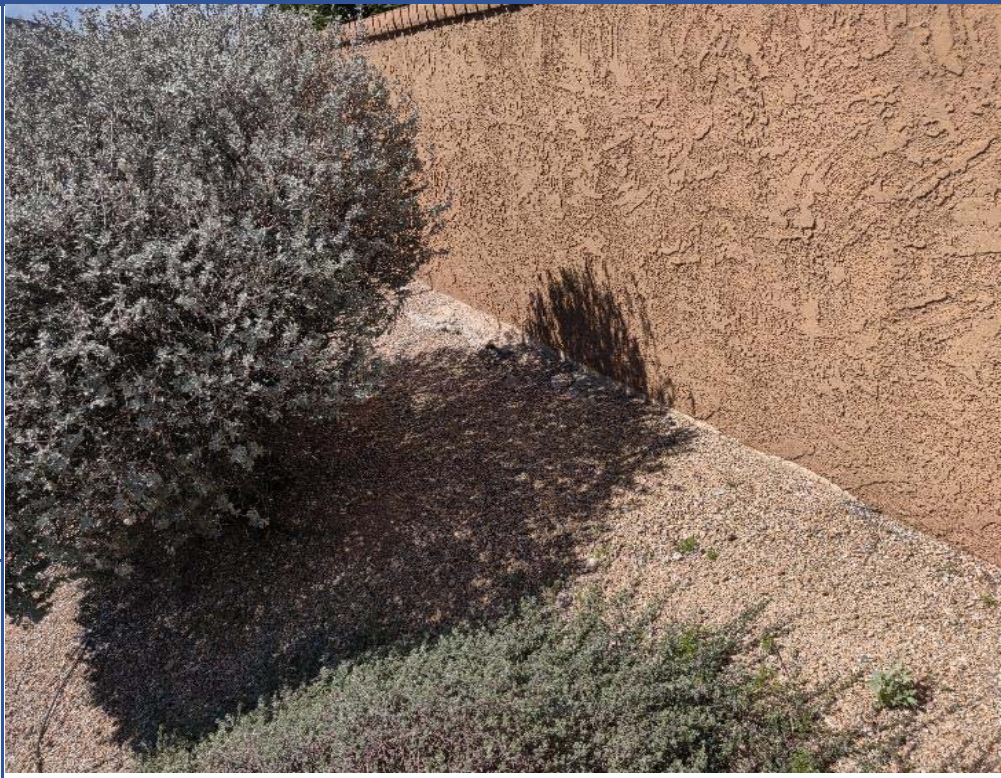
Perimeter wall with exposed footing along Hum Road

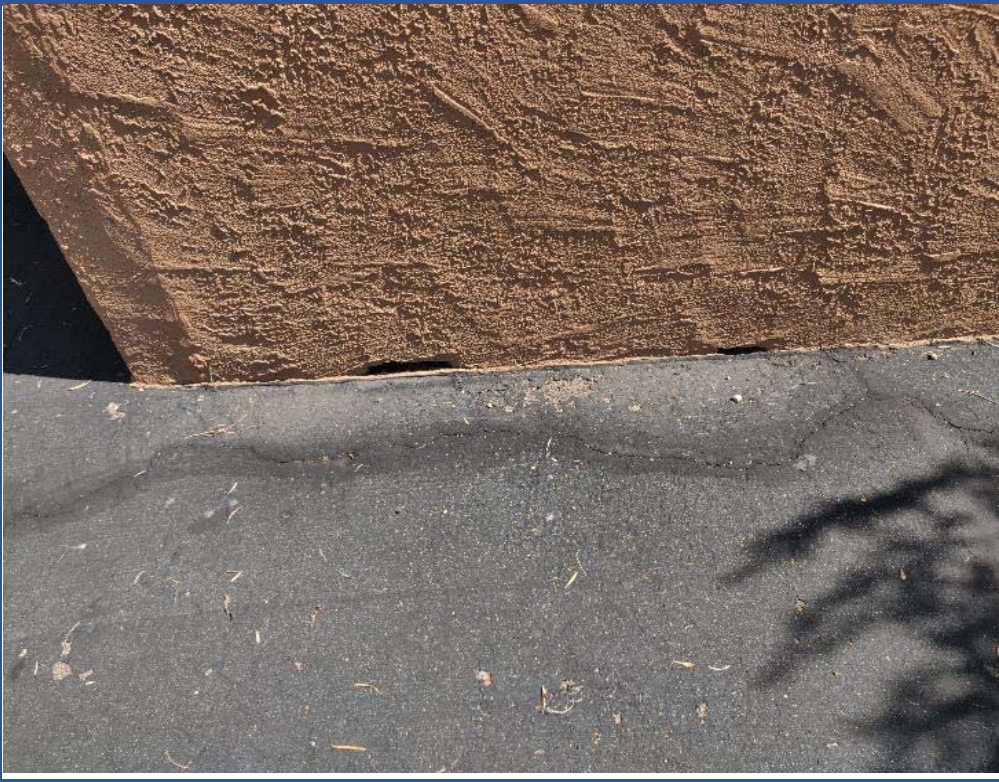
40

Trash receptacle enclosure - gaps near the bottom of the rear of the cmu enclosure

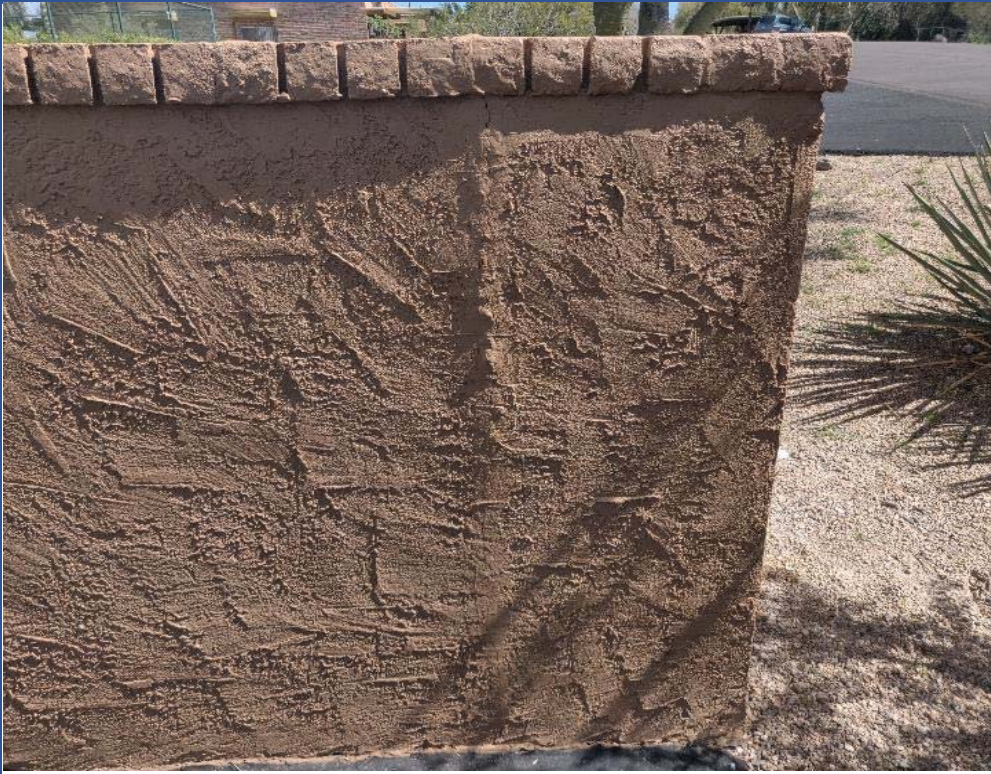
41

Vertical seam in the enclosure, potentially either widened or previously repaired

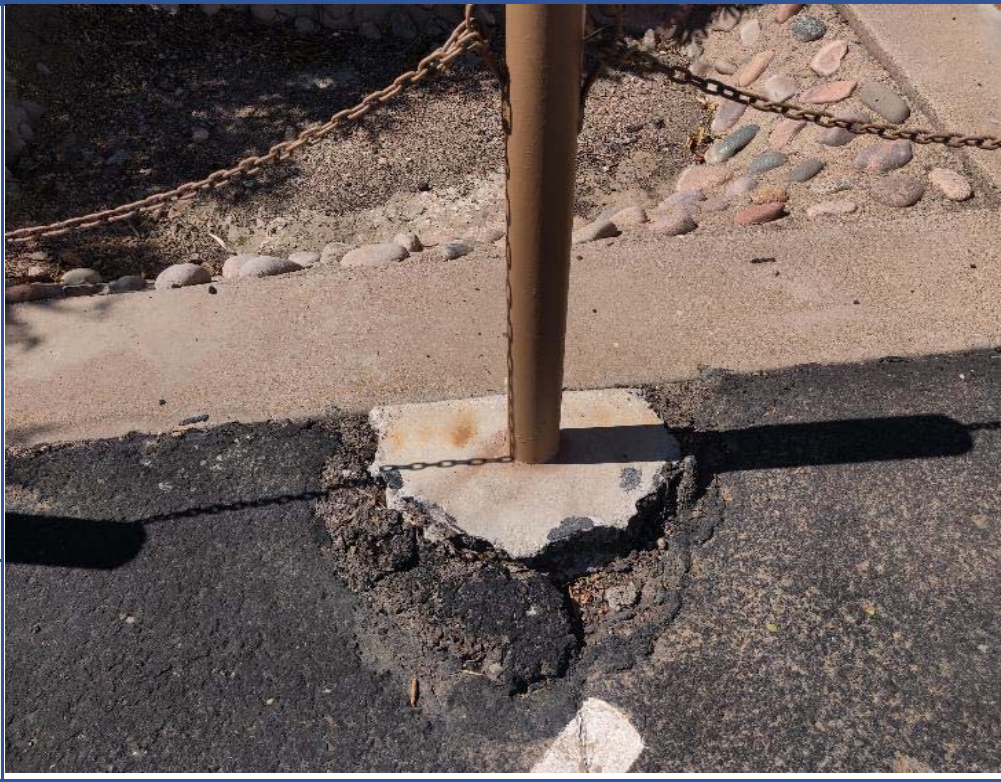
58

Post footing has been uplifted - likely due to a past collision

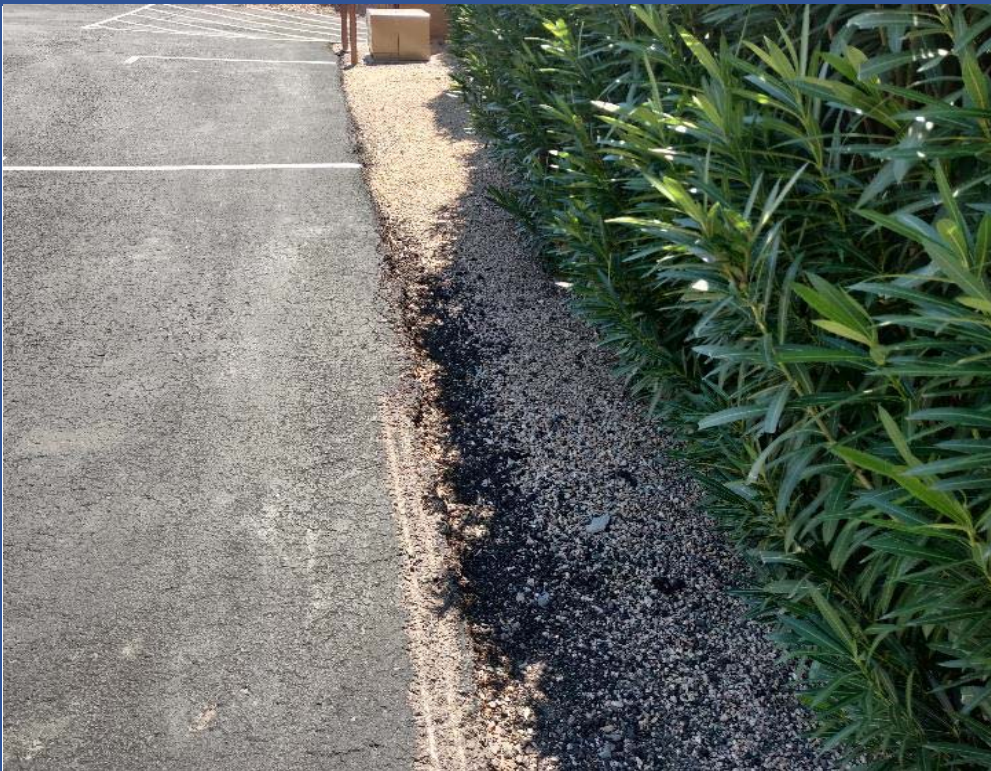
60

Asphalt edge cracking.  
This is due to a lack of support along the edge.

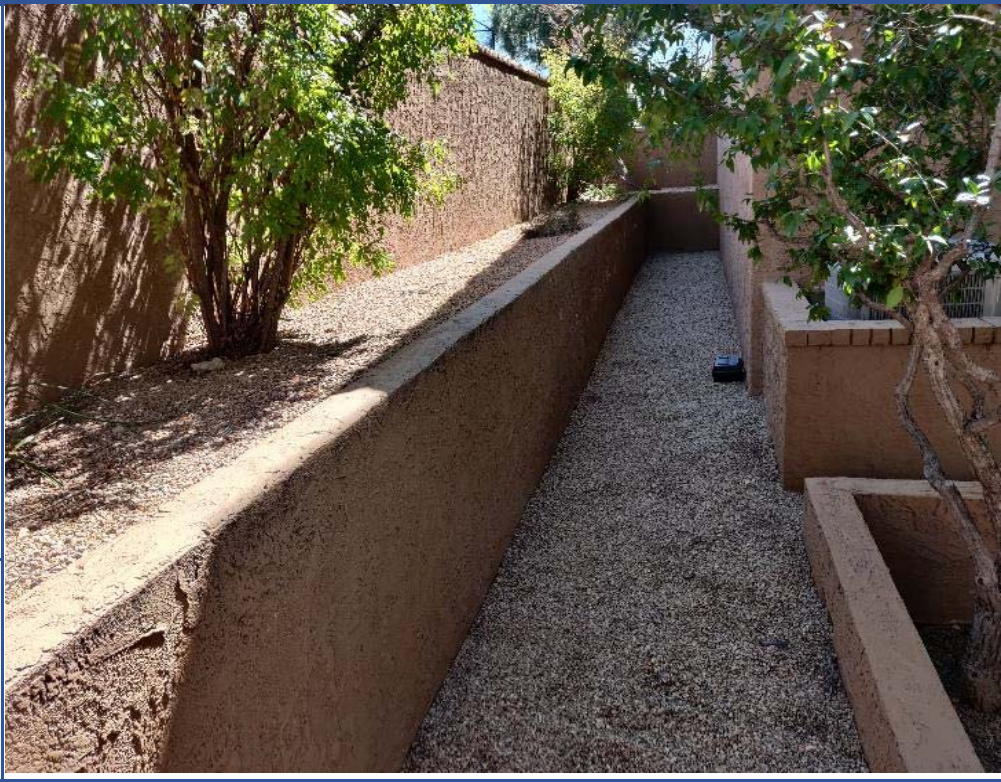
**65**

Retaining walls - no visible weep holes

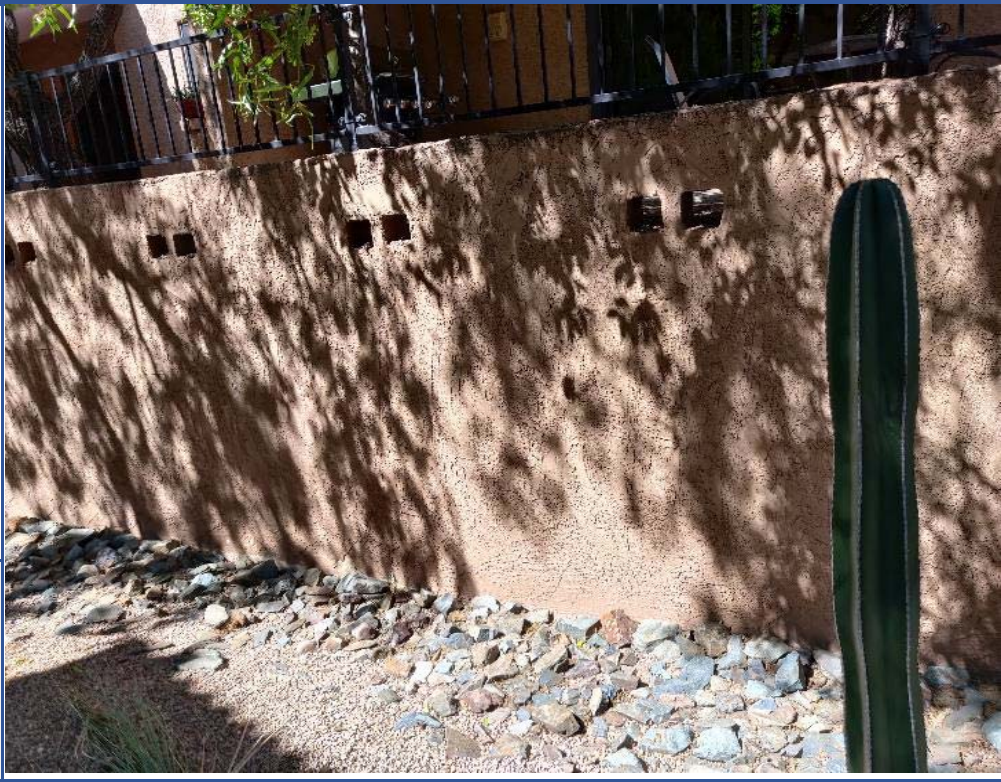
**66**

Retaining walls with side turned blocks for surface drainage but no visible weep holes

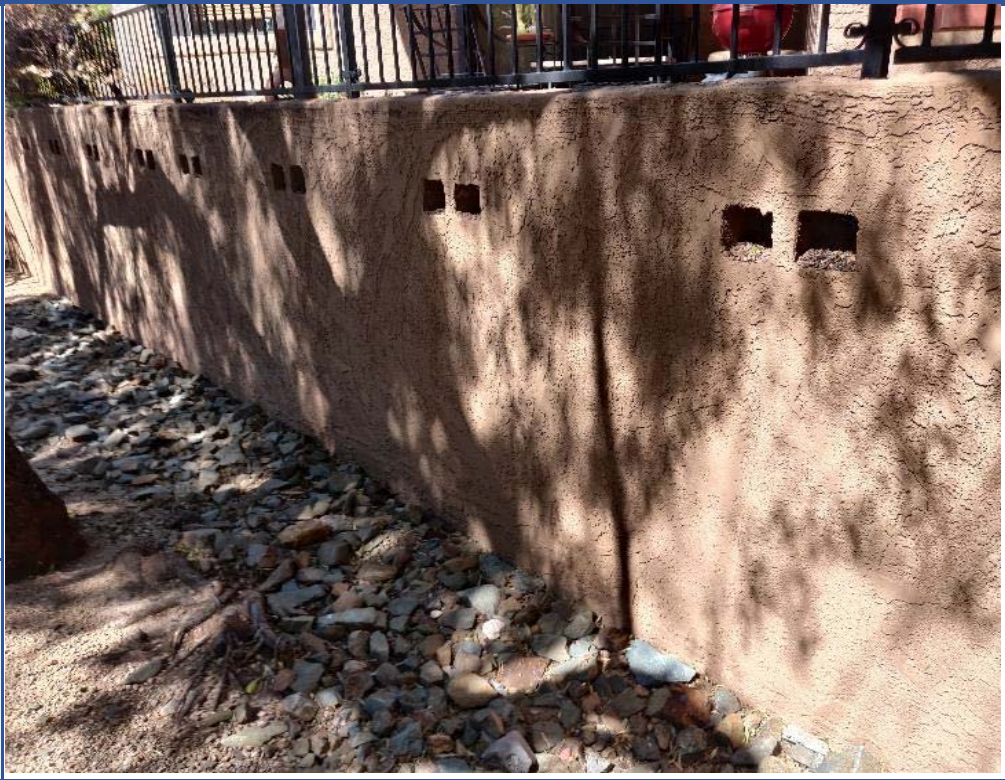
Retaining walls with side turned blocks for surface drainage but no visible weep holes

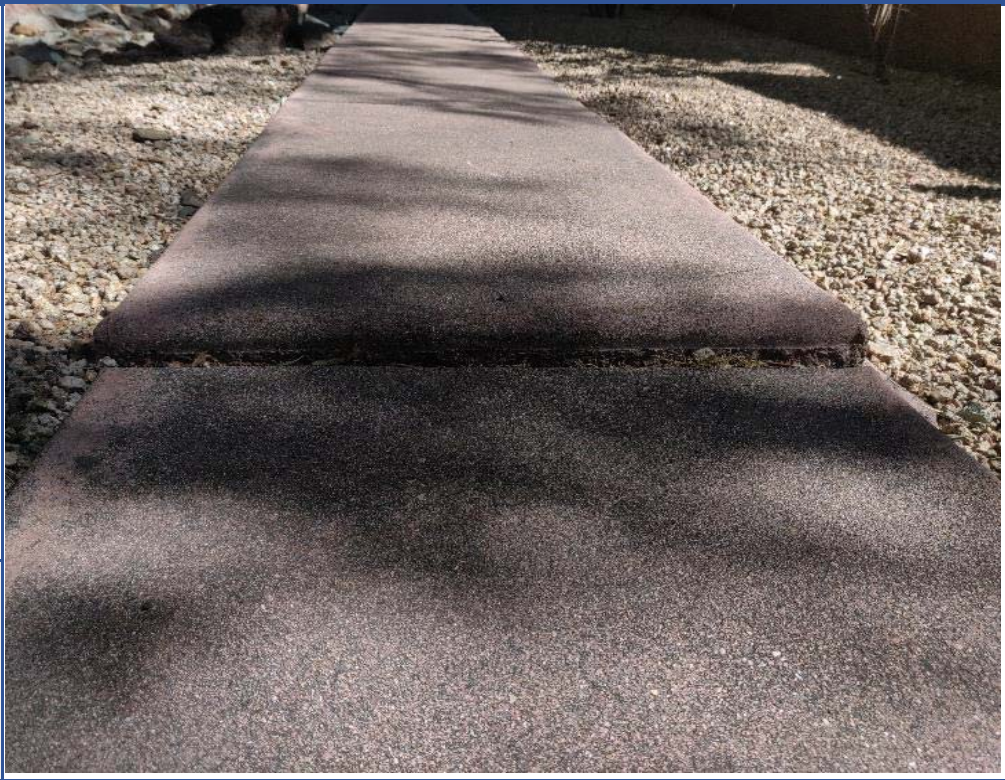
Concrete sidewalk uplift

- ✓ Concrete walkways - Repair / Replacement – Funds will accumulate over time and should be used as needed to repair or replace sections of the concrete walkways. If no repairs are needed, these funds may be set aside for wholesale replacement of a larger section at a later date.

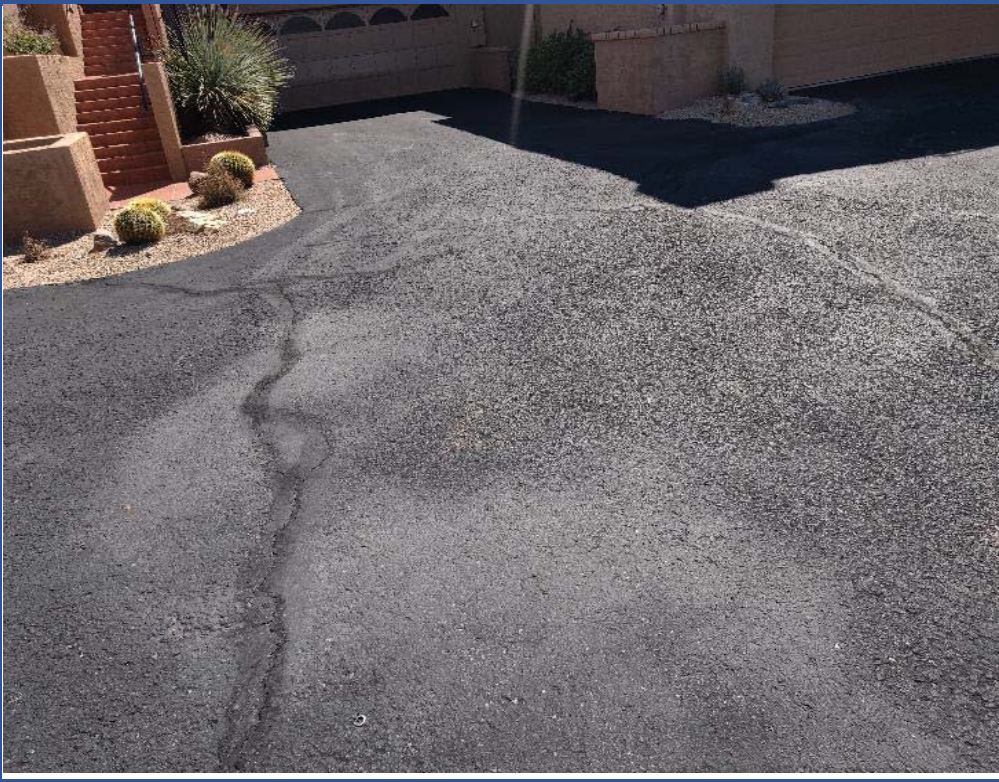
**80**

Asphalt loss of aggregate
