August 01, 2015

COMMUNITY ASSET EVALUATION

## Las Torres

Cave Creek, Arizona

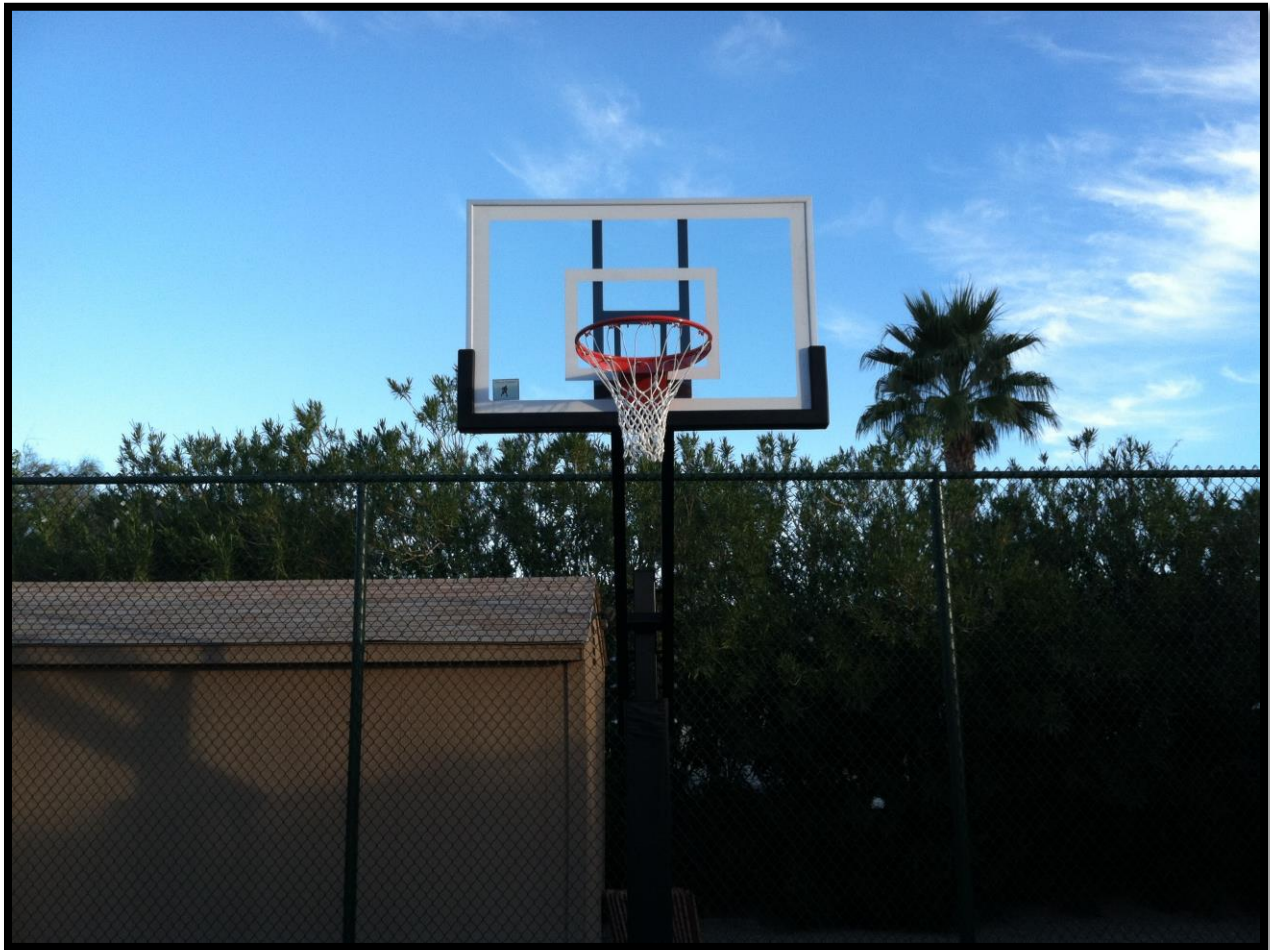
<b>Asset #107</b>	<b>Basketball Backboard</b>	<b>Quantity</b>	<b>1</b>
<b>Constructed</b>	2012	<b>Current Cost to replace</b>	\$2,240.00
<b>Useful Life</b>	20 years	<b>Cost to Replace 2032</b>	\$3,595.00
<b>Years Remaining</b>	19 years

The basketball goal system is in new condition and was installed in 2012. It is critical to maintain all assets and we recommend having a sports equipment maintenance professional inspect all outdoor equipment a minimum occurrence of one time per year. This will ensure the longevity of the asset. Tax and removal of existing assets have been included in the unit pricing.

1 Flextreme Model 454 Basketball goal assembly@ **\$2,240.00**

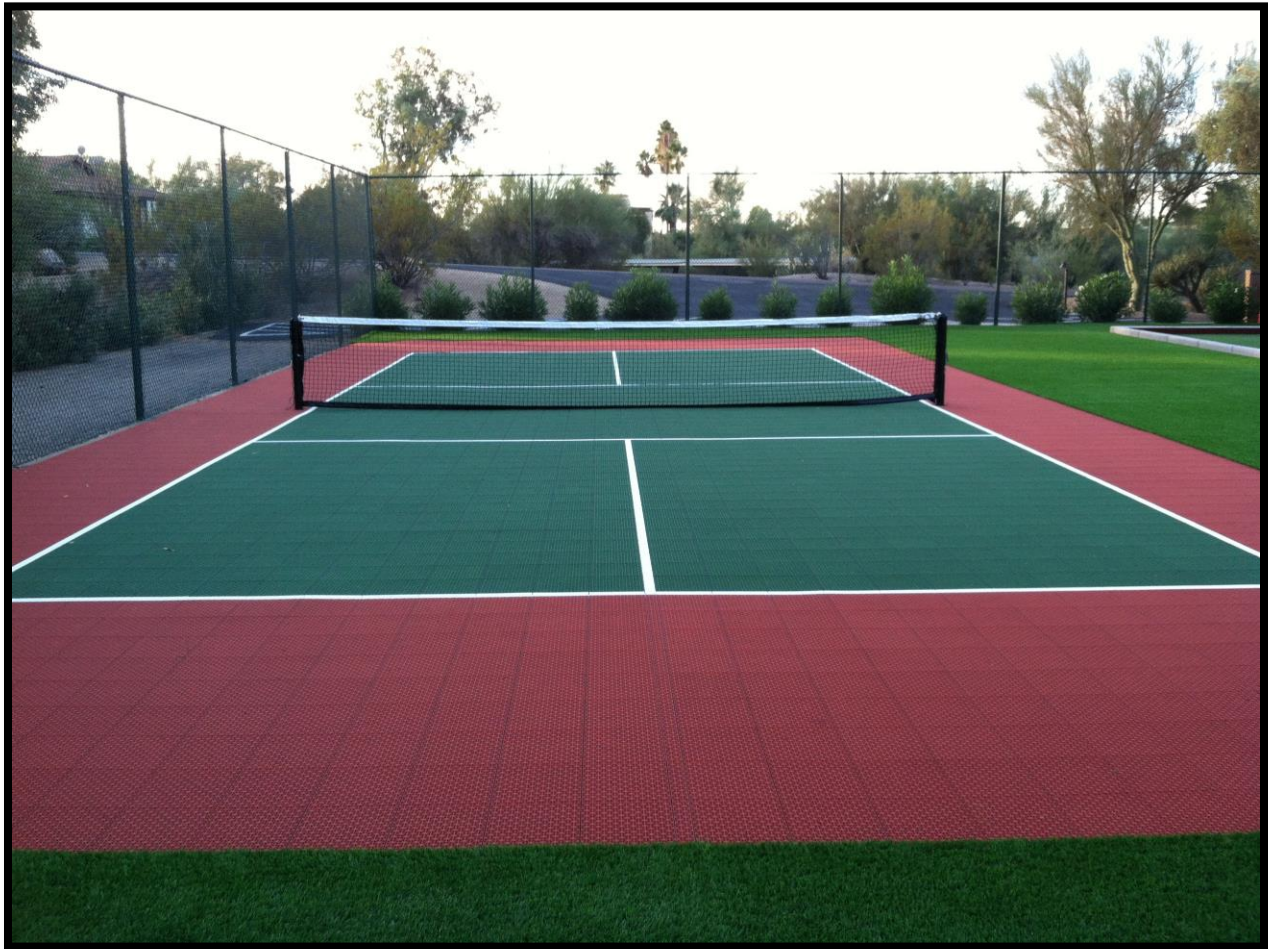
<b>Asset #108</b>	<b>Flex Court Replacement</b>	<b>Quantity</b>	<b>6,344 SQ FT</b>
Constructed	2012	Current Cost to replace	\$21,253.00
Useful Life	25 years	Cost to Replace 2037	\$40,723.00
Years Remaining	22 years

The Flex Court system in your community is new and was installed in 2012. Per manufacturer’s information, the court system is designed to exceed 20 years of useful life prior to needing replacement. We have estimated a useful life of 25 years as a result. It is critical to maintain all assets and we recommend having a sports equipment maintenance professional inspect all outdoor equipment a minimum occurrence of one time per year. This will ensure the longevity of the asset. Tax and removal of existing assets have been included in the unit pricing.

6,344 square feet of acrylic color material, to include prep work, @ \$3.35 per square foot = **\$21,252.40**

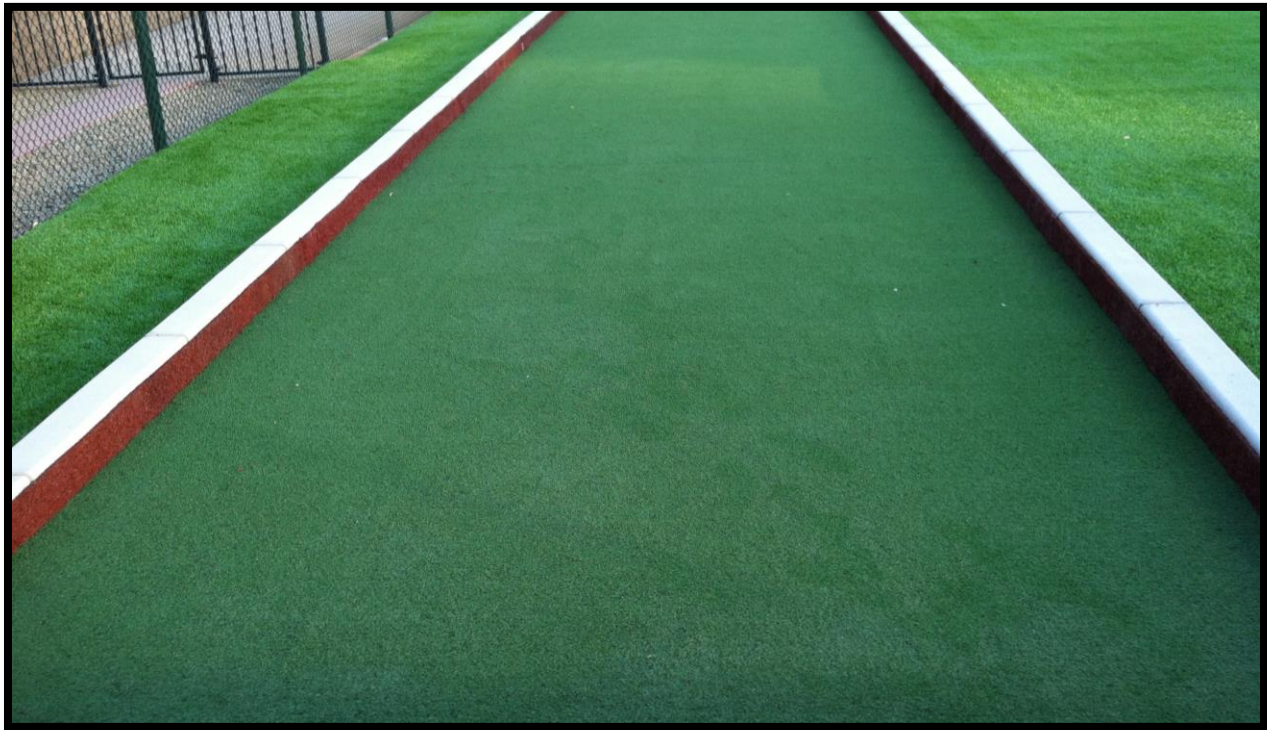
<b>Asset #109</b>	<b>Synthetic Turf Replace</b>	<b>Quantity</b>	<b>2,120 sq ft</b>
Constructed	<u>2012</u>	Current Cost to replace	<u>\$12,720.00</u>
Useful Life	<u>10 years</u>	Cost to Replace 2022	<u>\$15,646.00</u>

The current condition of the material seems to be good however there is obvious wrinkling which may indicate soil movement or poor installation methods. We recommend the association have the installer or another certified contractor investigate and repair the subgrade, the relay the existing material. This product has a 10 year warranty and all warranties should be used before replacement at the association’s expense.

The synthetic turf in the community was manufactured by Global Syn-Turf who provides a limited warranty of 10 years along with a workmanship warranty of 1 year provided by Eco Turf, the installer. We recommend the association conduct a 1 year walk through with the installer to identify warranty concerns prior to the termination of warranty. It would be reasonable to schedule the walk thru 30 days prior to the warranty termination giving the contractor ample time to make any necessary repairs. We have estimated all ancillary expenses associated with the removal and replacement of this asset. Based on the manufacturer’s information we have estimated the useful life of this component to be 10 years.

Approximately 2120 square feet of Synthetic Turf removed and replaced @ \$6.00 each = **\$12,720.00**

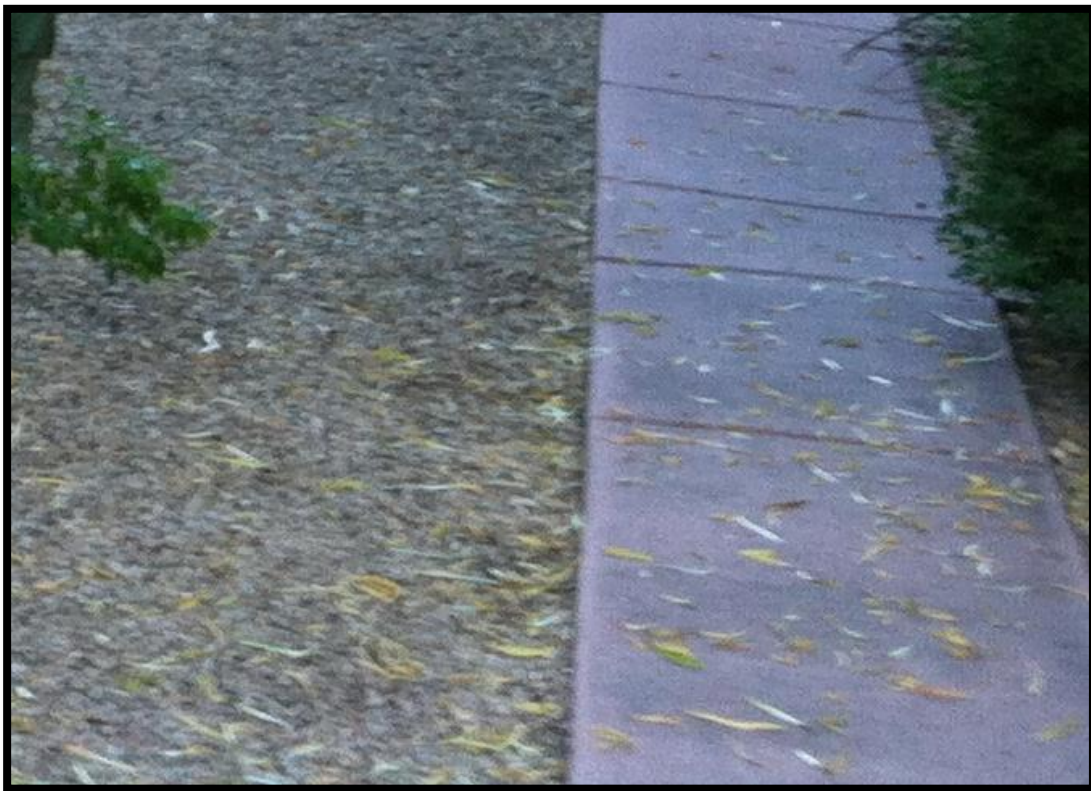
<b>Asset #118</b>	<b>Concrete Components</b>	<b>Quantity</b>	<b>NA</b>
<b>Constructed</b>	<u>Assumed 1979</u>	<b>Current Cost to Maintain</b>	<u>NA</u>
<b>Useful Life</b>	<u>15 year maintenance schedule</u>	<b>Cost to Maintain 20</b>	<u>NA</u>

The sidewalks and cool deck are the only real concrete components in this community that are visible. We typically provide a concrete budget for curb gutter and valley gutters at the time of repaving however, this community does not have these assets so we have not funded concrete in this report. Concrete has an undeterminable useful life and can last the life of the community. We do recommend making any necessary safety repairs immediately using your contingency line in the reserve study or out of your annual operating budget. If repairs are needed, we recommend all sub-grade of removed concrete to be compacted to a minimum 95% using MAG AA w/ Fiber mix and #5 epoxy coated rebar dowels to ensure replaced pieces do not move or float.

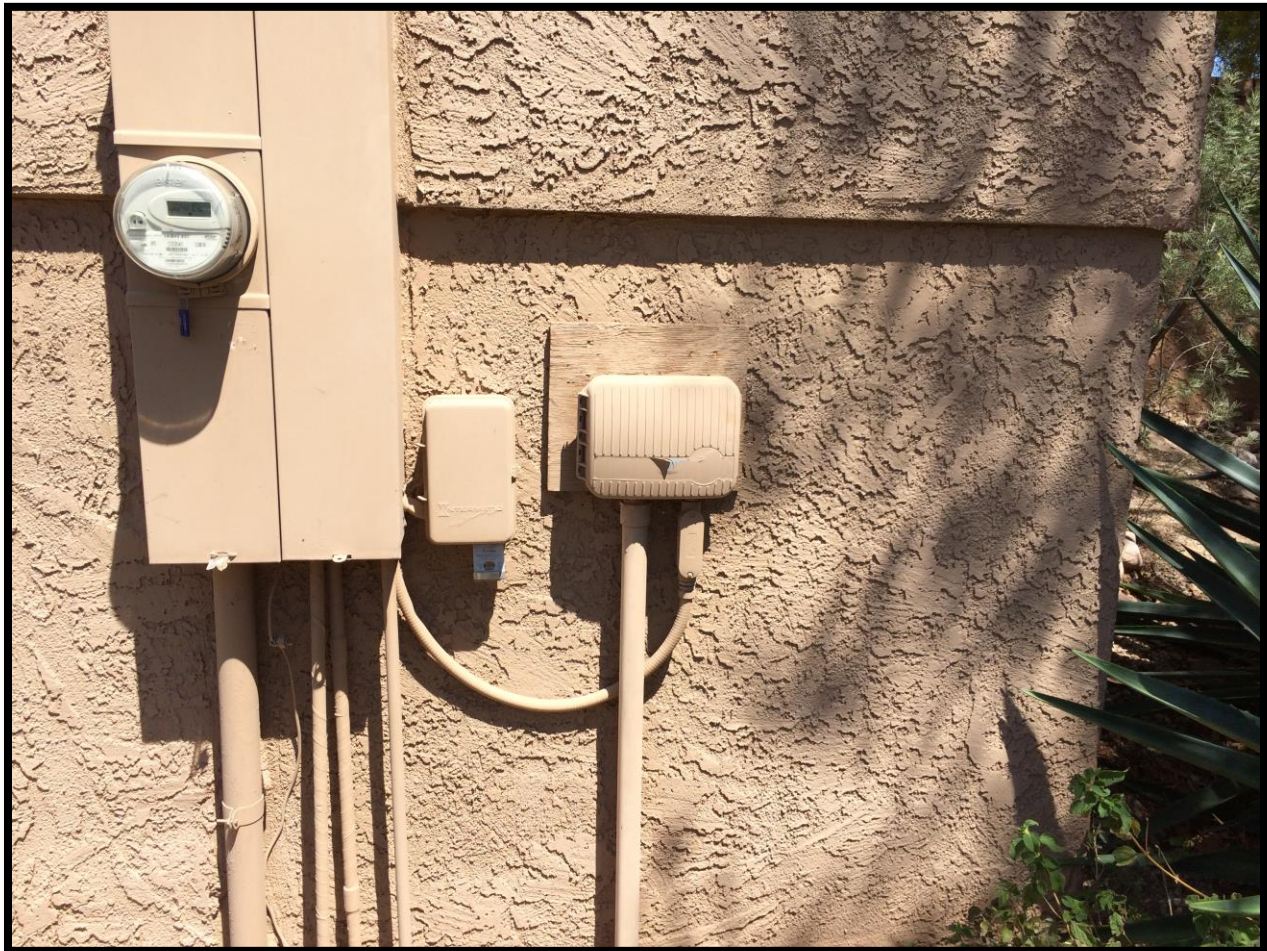
<b>Asset #119</b>	<b>Irrigation Controllers</b>	<b>Quantity</b>	<b>1</b>
Constructed	Assumed 2002	Current Cost to replace	\$1,950.00

These components appear to be in good condition and have a useful life ranging from 8 to 15 years depending on use and exposure. We have estimated the useful life of these components to be 12 years.

This component controls the electric landscape valves.

**This Price includes removal, replacement, valve ID and reprogramming.**

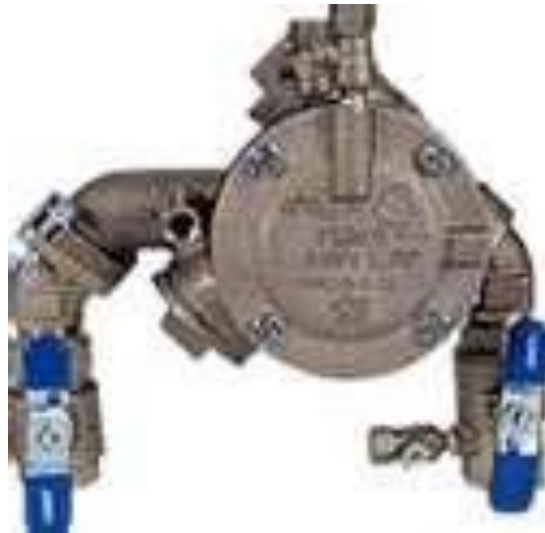
Asset #120 Backflow Preventers Quantity 3

This component separates the potable drinking water from the landscape water preventing backflow of stagnant water that carries harmful bacteria in to the city water. These components have a useful life of 15 to 20 years before needing replacement. We are not sure when this component was last replaced but we are assuming they have been replaced at least one time since the community has been in service. We have used 2001 as an estimated replacement date based on the age of the community.

3 – 1 ½” Febco 825YA backflow devices w/ cage removed and replaced @ \$1,650.00 ea TOTAL = **\$4,950.00**

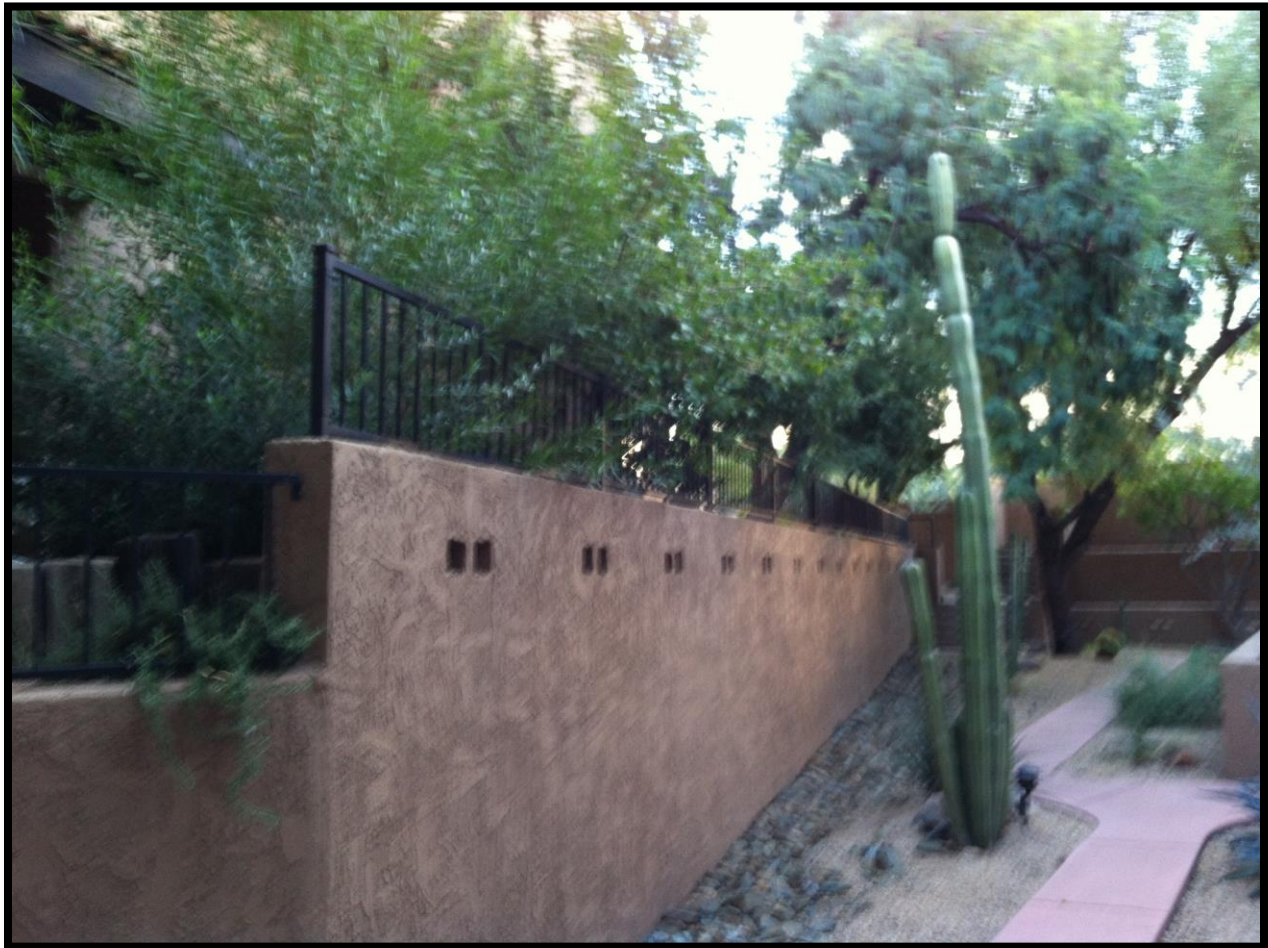
The masonry wall in this community is made of an 8”X6”X16” block, fully grouted with concrete and rebar /bond beam reinforced. Due to the construction specs of this component it should last the life of the community providing it is maintained as needed. There will be a need to repair this component at some time and we are providing funding for this purpose. The need for repair may be less, or exceed the provisions we have made and can be adjusted over time.

\$5,000.00 every 10 years starting in year 35, or 2021, will be funded for maintenance purposes.

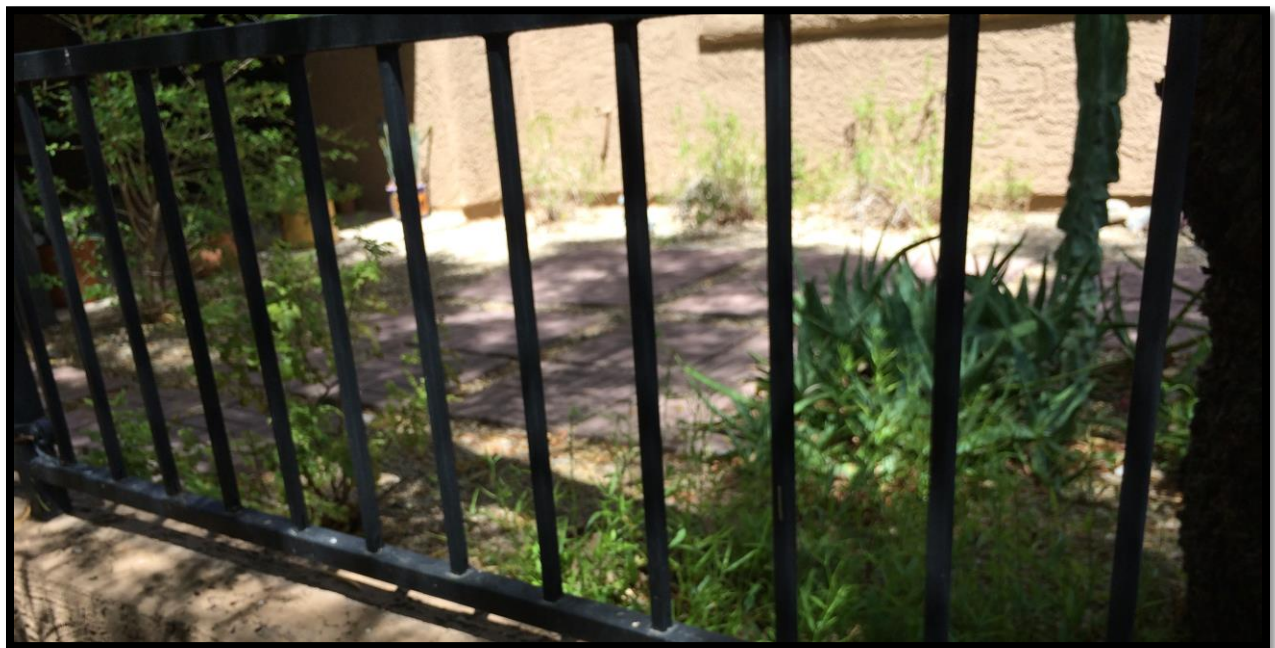
Asset #126A	Wrought Iron Replacement	Quantity	See Below
Constructed	Unknown	Current Cost to replace	\$19,790.00
Useful Life	30 years	Cost to Replace 2042	\$43,959.00
Years Remaining	29 years		
Replacement	2042

The wrought iron is in great condition with no signs of rusting or paint failure. We are not sure if this is the original Iron Fence or not but we have estimated 29 more years of useful life for this asset providing it is well maintained and painted/ repaired as needed.

**Improper use, such as climbing, vehicle damage or vandalism will contribute to the degradation of this component. We recommend that these components be inspected by a professional on an annual basis to ensure appropriate maintenance is being scheduled.**

Approximately 1150 square feet of Wrought Iron Fence removed and replaced @ \$12.00 each = **\$13,800.00**

2 Metal stairwells removed and replaced @ \$2,050.00 each = **\$4,100.00**

3 Metal 6’ Iron Gates removed and replaced with locks @ \$690.00 each = **\$1,890.00**

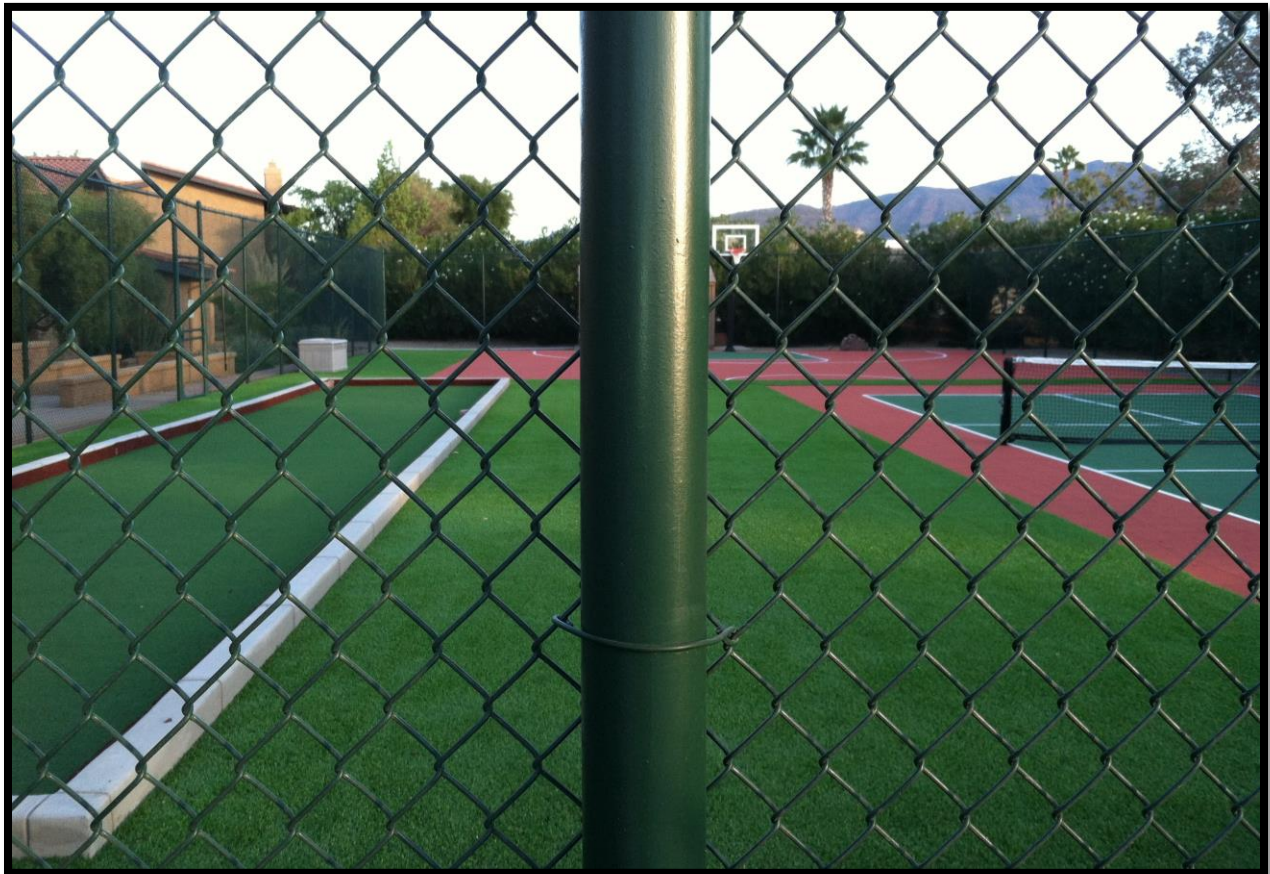
<b>Asset #126B</b>	<b>Chain Link Fence Replacement</b>	<b>Quantity</b>	<b>3,600 Sq Ft</b>
Constructed	2012	Current Cost to replace	\$13,680.00
Useful Life	30 years	Cost to Replace 2042	\$30,387.00
Years Remaining	27 years		
Replacement	2042

The chain link was installed in 2012 along with the repainting of the existing poles. We recommend this asset be inspected annually and paint touch ups made immediately in an effort to extend the useful life of this component. The cost of this asset has increased exponentially from the previous report. These numbers were provided by American Fence. It is my opinion that more chain link is being installed driving up the cost based on demand.

**Improper use, such as climbing, vehicle damage or vandalism will contribute to the degradation of this component. We recommend that these components be inspected by a professional on an annual basis to ensure appropriate maintenance is being scheduled.**

Approximately 3,600 square feet of 11 gauge 1 3/4" mesh Chain Link Fence @ \$3.80 each = **\$13,680.00**

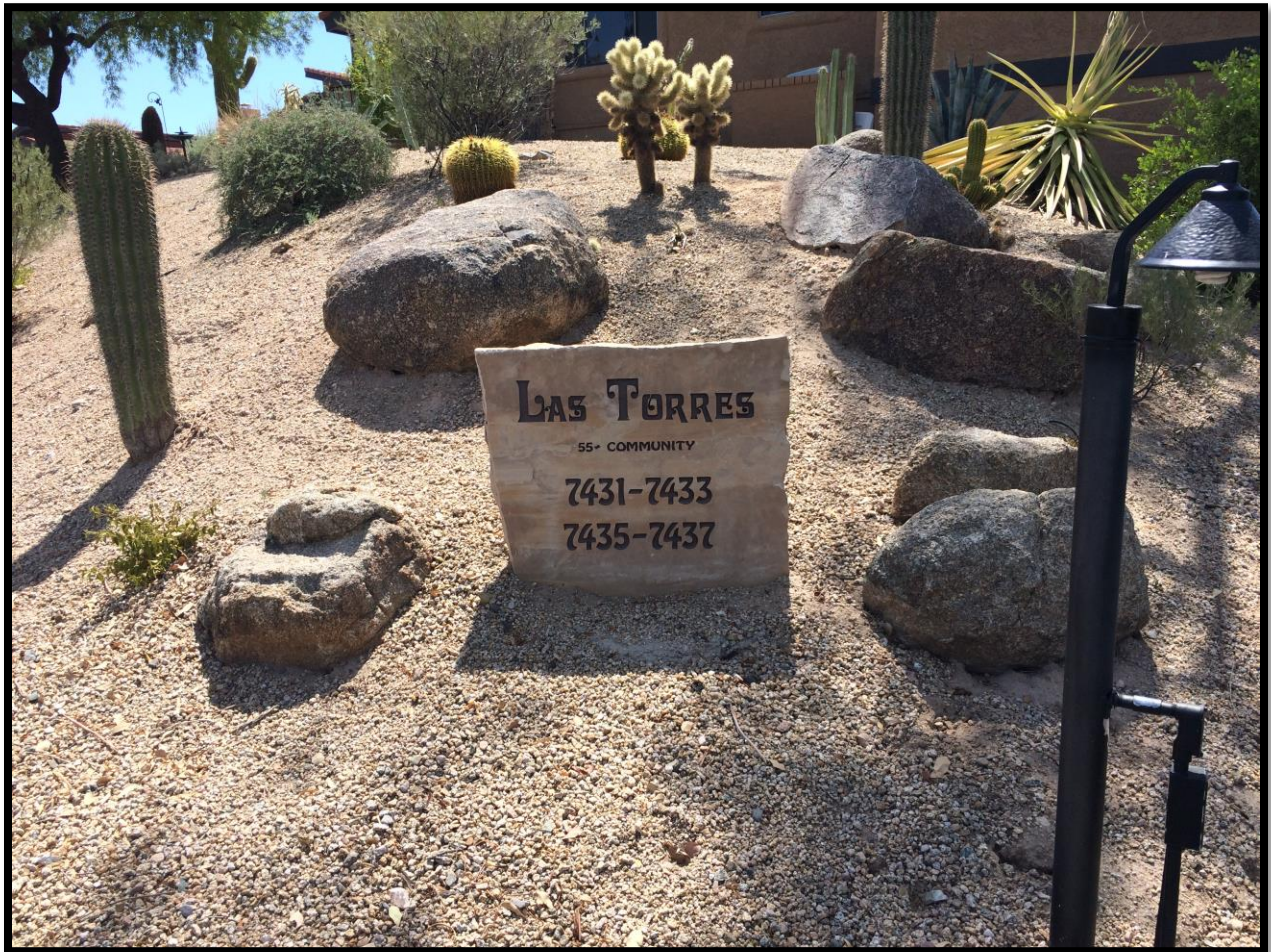
<b>Asset #135</b>	<b>Monument Letter Replacement</b>	<b>Quantity</b>	<b>3</b>
Last Installed	Unknown	Current Cost to Replace	\$3,000.00
Useful Life	20 + years	Cost to Replace 2032	\$4,814.00
Years Remaining	17 years		
Replacement	2032

The 2 etched stone monument signs are in great condition and has a average useful life of 20+ years before needing replacement. Applying clear sealants every couple years will extend the useful life of the component, possibly beyond the 30 year scope of this report. Specific information regarding the age of this component was available so we have estimated 20 years of existing life in this asset.

3 – Etched pieces of 1 ½” to 2” thick flag stone, removed and replaced at \$1,000.00 each = **\$3,000.00**

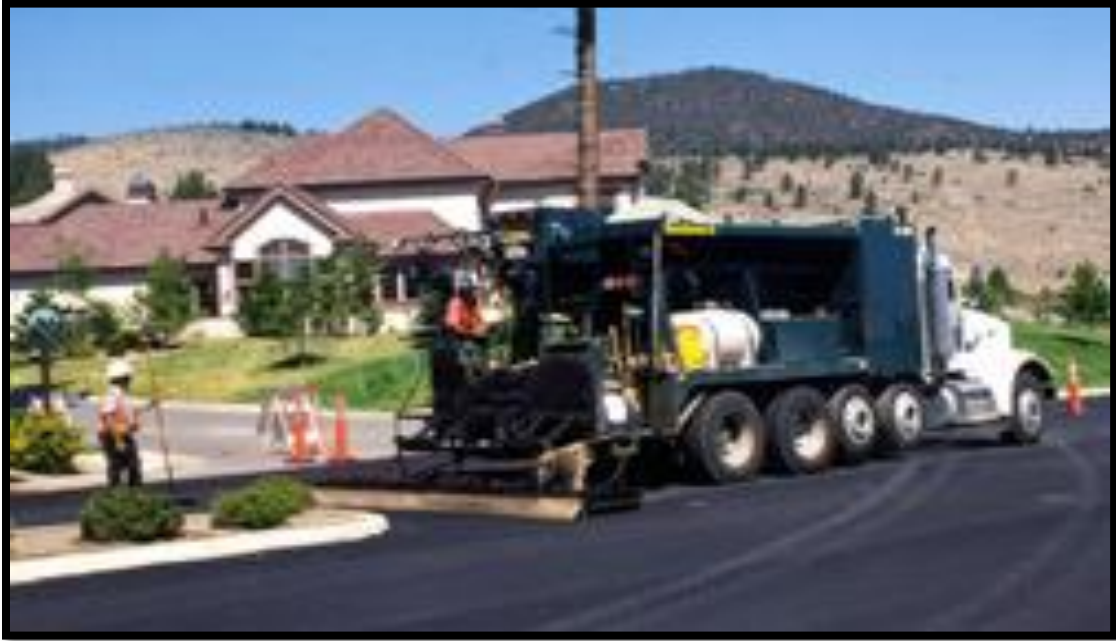
**SEAL COATING**

Sealants and Crack Sealants can last up to 5 years but may be adjusted based on the use and exposure of the streets, and the type of sealants used. Drainage is also a big factor as some asphalt is designed to carry storm water and others are sloped from the center to divert the water to curb gutters and valley gutters. We highly recommend the use of Master Seal Asphalt Emulsion MTR for the seal coat as these products last longer than other types of sealants. We also recommend crack seal for all utility adjustments and anywhere the asphalt meets the concrete. Any cracking ¼” or wider in the asphalt will also require a rubberized crack sealant. This will prevent moisture from penetrating in to the sub-grade and prevent asphalt movement and excessive cracking. These numbers include the cleaning of the roads 2 times prior to the applications. Rain or excessive humidity will delay drying time. After replacement it is critical to maintain the asphalt as needed. We have a fog seal coat budgeted in for 2042 as the new asphalt will need the additional oil within the first year for best maintenance practices.

Approximately 1,000 LF of crack Seal @ \$0.53 per LF = **\$400.00**

Estimated Asphalt repairs prior to seal coat = **\$1,000.00**

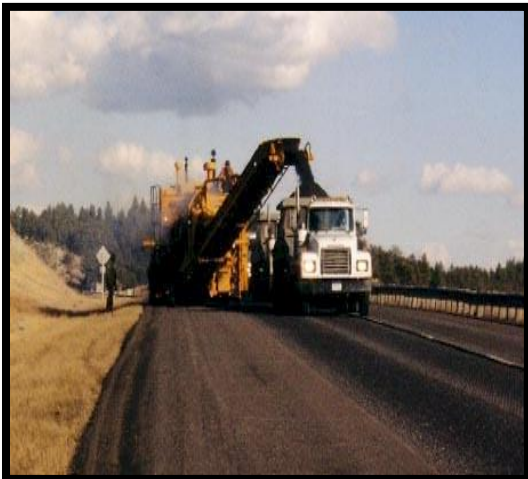
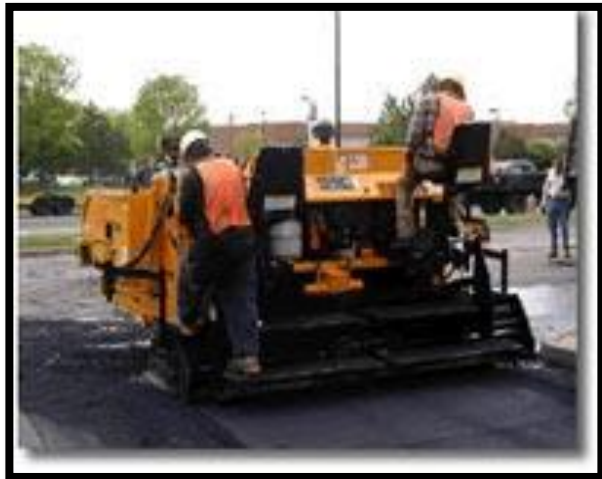
**MILLING AND OVERLAY OF NEW ASPHALT**

Asphalt typically has a 20 to 30 year useful life before an overlay, or replacement, will be necessary. This is determined on how the asphalt was designed and built, and how well the asphalt has been maintained and the exposure and use of this component. We have assessed the useful life of this component to be 30 years based on the current condition and minimal use. We highly recommend the use of a Survey company for establishing sub-grade drainage and locating utility adjustments need to be removed and replaced and for drainage purposes on the finish elevation of the asphalt. We further recommend the use of a Geotechnical Firm to for material samples and density testing of the finished product to ensure the asphalt is being installed per municipal specifications ensuring the product and workmanship provided by the contractor. We recommend asphalt replacement, pulverizing and removing existing material. Some material may be used to improve the grade which will reduce removal and trucking fees. Mature communities may run in to extra costs as the sub-grade material might not be reusable and in some cases, does not exist. An alternate is to use the asphalt millings to establish a sub-grade base which would relieve some of the removal trucking fees but will require additional survey time, density testing and labor.

We highly recommend that the HOA hire a third party to manage and inspect the mill and overlay process. This is a service we can provide but there are many qualified agencies to choose from.

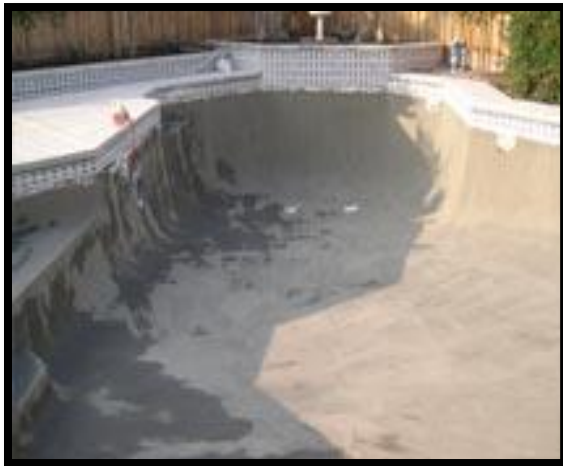
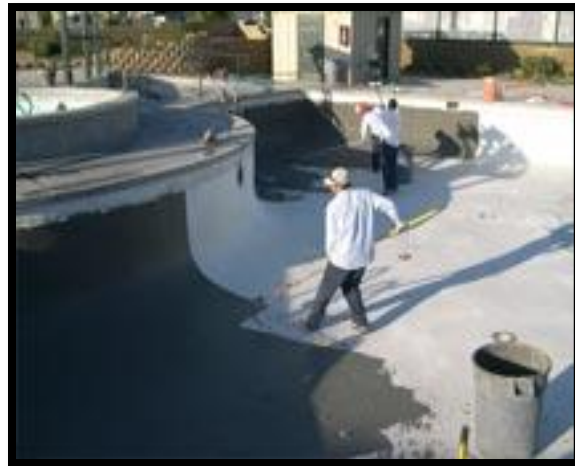
<b>Asset #301</b>	<b>Pool Resurfacing</b>	<b>Quantity</b>	<b>1,450 Sq Ft</b>
<b>Constructed</b>	2002	<b>Current Cost to Resurface</b>	\$13,703.00
<b>Useful Life</b>	15 years	<b>Cost to Resurface 2017</b>	\$29,539.00
<b>Years Remaining</b>	2 years	<b>Cost to Resurface 2032</b>	\$22,651.00

The pool surface appears to be in good condition for its age. We have funded for pebbletec based on new information provided by one of the Board Members. Depending on many different factors such as element exposure, use, chemical applications, etc the useful life of this component increase or decrease. As we do not know the when the last time the pool was resurfaced we are giving this component a useful life of 15 years until the next application in 2017. We have also included an additional \$15,000.00 for county requirements on the drains in 2017. This is based on an average of what we have been told by many different pool companies making repairs between \$9,000.00 and \$20,000.00. This is based on unknowns when excavating.

Approximately 1,450 sq ft of plaster replacement @ \$8.30 per sq ft = **\$12,035.00**

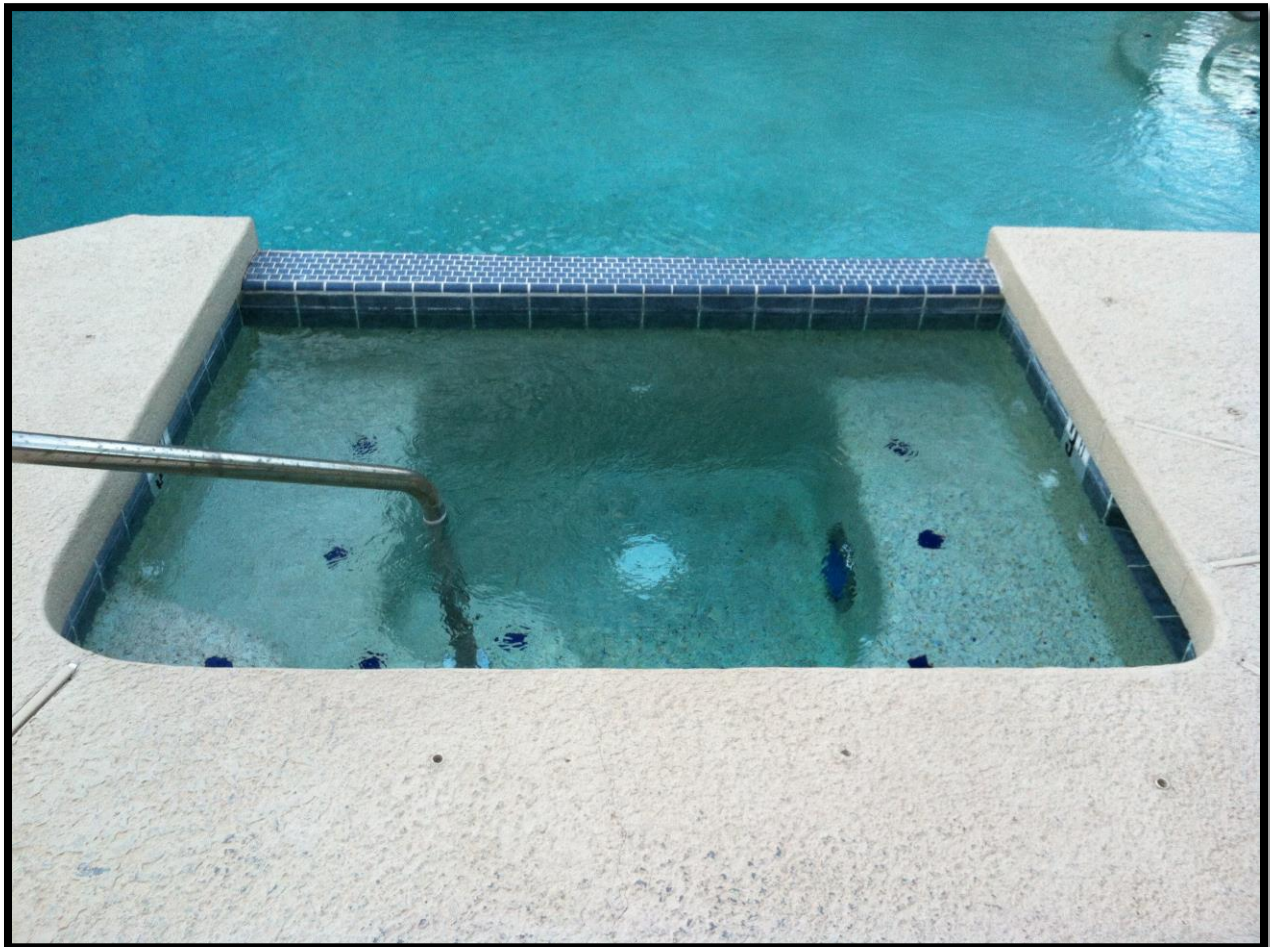
<b>Asset #301A</b>	<b>South Pool / Spa Resurfacing</b>	<b>Quantity</b>	<b>150 sq ft</b>
<b>Constructed</b>	2002	<b>Current Cost to Resurface</b>	\$1,692.00
<b>Useful Life</b>	15 years	<b>Cost to Resurface 2017</b>	\$1,795.00
<b>Years Remaining</b>	2 years	<b>Cost to Resurface 2032</b>	\$2,797.00

The spa surface appears to be in good condition. Pebble Tec has a typical useful life ranging from 13 to 18 years depending on chemical use and exposure. We have estimated the useful life to be 15 years and have assumed there is a remaining 7 years of existing life before replacement is needed.

Approximately 150 sq. ft. of Pebble Tec replacement @ \$8.30 per sq ft = **\$1,245.00**

Approximately 41' tile @ \$10.90 per ft = **\$446.90**

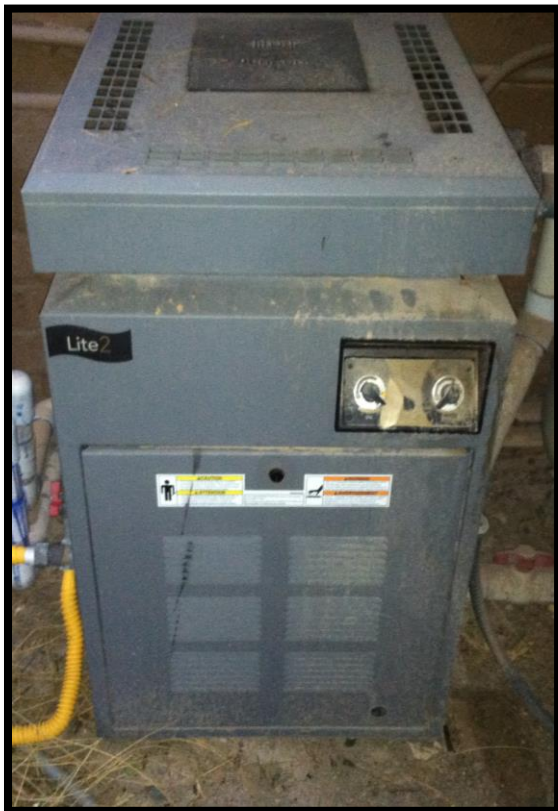
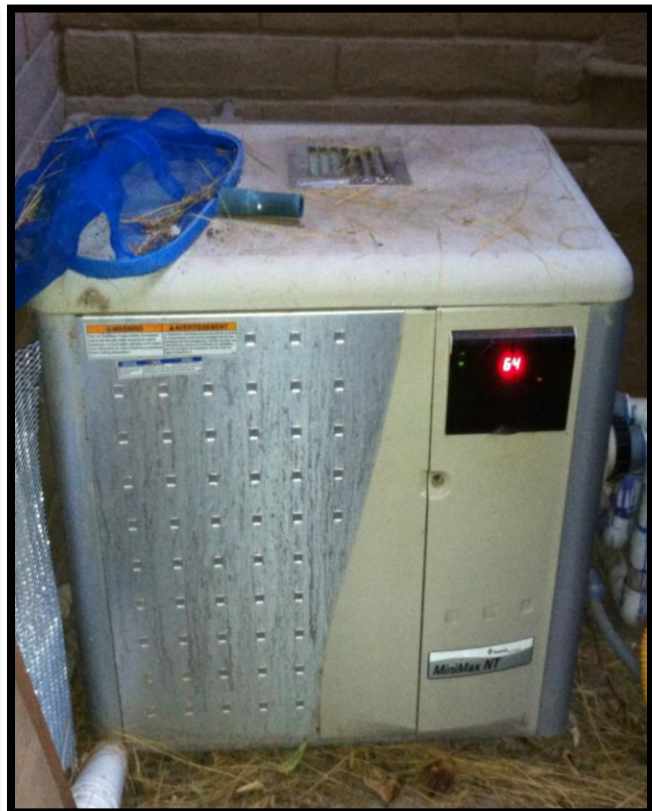
We have assumed the pool/ spa heaters were replaced in 2007 based on their current condition. One of the heater was not operational at the time of the inspection so we are not sure if the component needs repair. These components have a useful life that averages from 7 to 12 years depending on frequency of use, exposure and maintenance practices and should be inspected regularly by a licensed professional. For uniformity purposes we have funded for the same brand of heaters in lieu of the 2 different manufacturers as displayed in the photos. Makes and models are often discontinued in which case we use the closest comparable models.

1 Pentair 400K BTU Master Temp Low Nox Natural Gas heater @ **\$3,000.00**

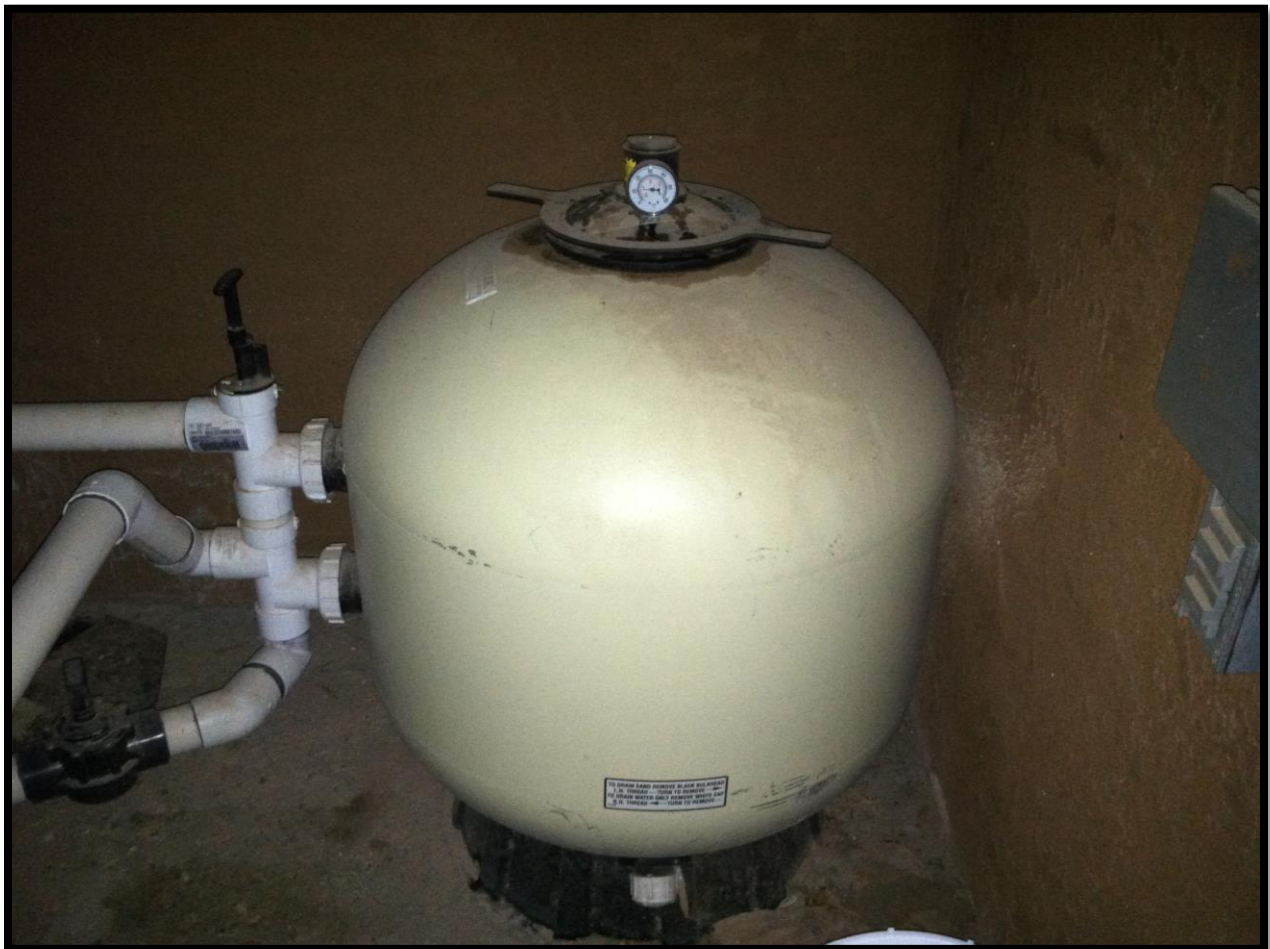
The filters were not in operation at the time of the inspection but there were no visible defects with these components. Pool filters have a useful life ranging from 8 to 20 years depending on use, exposure, proper maintenance, etc. These components are estimated with a useful life 18 years. Replacements have been estimated by the Associations contracted pool vendor.

1 Pentair Triton II TR60 Commercial Sand Filter @ **\$1,200.00**

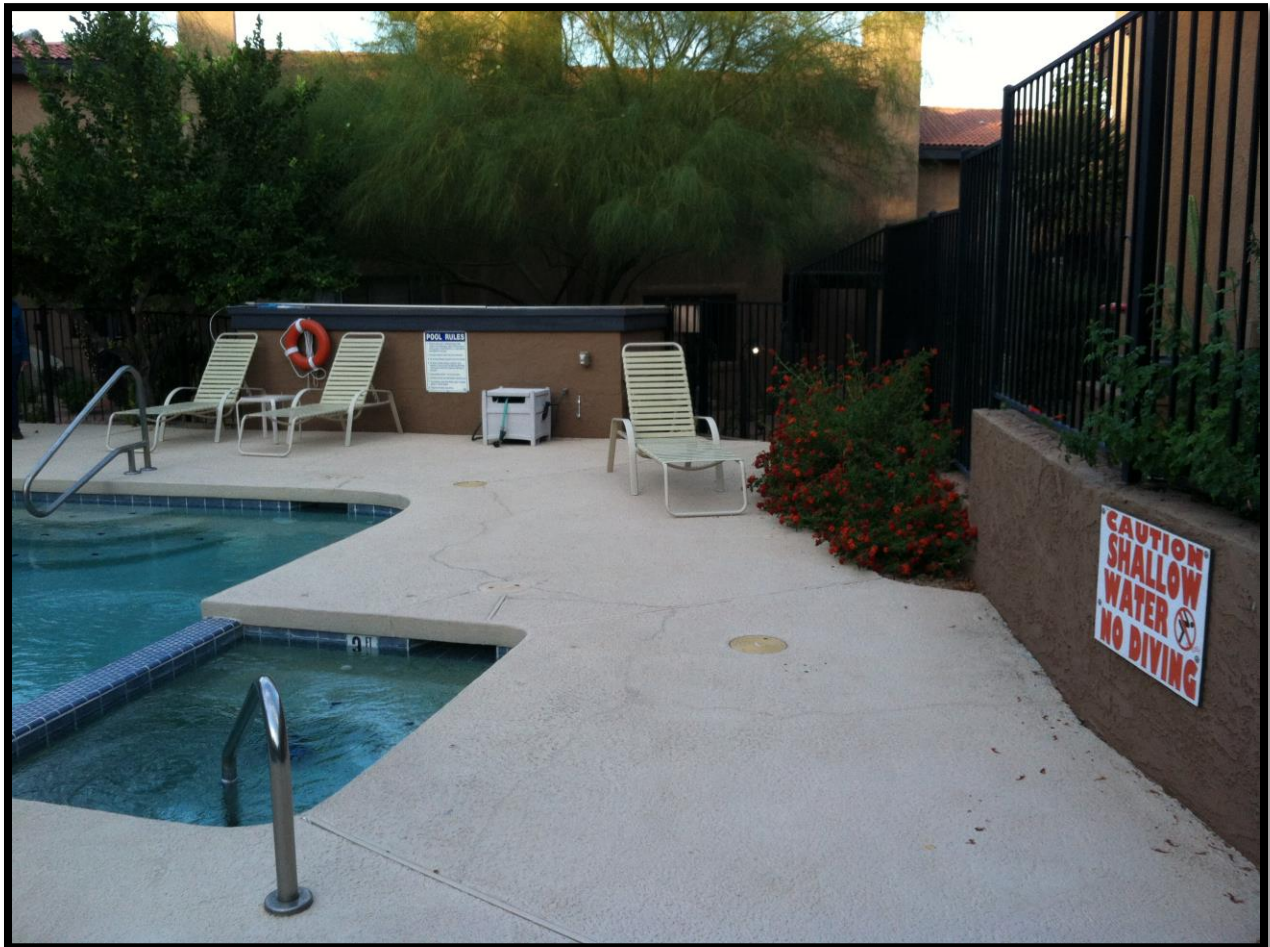
Asset #314	Cool Deck	Quantity	1,735 sq ft
Constructed	2015	Current Cost to Resurface	\$13,013.00
Useful Life	15 years	Cost to Resurface 2030	\$19,683.00
Years Remaining	15 years	Cost to Resurface 2045	\$30,666.00
Current Unit Cost	\$7.50/ sq ft

We conducted a site visit as part of this reserve study and found the cool deck to be in good condition with the exception of the concrete slab under the cool deck. There are many cracks that are indicative of soil movement caused by water saturation. We recommend the Association have their landscape irrigation lines checked in this area as well as a pressure test on the pool plumbing. A large portion of the concrete slab will need to be removed and replaced prior to the next application of cool deck or a remodel changing to tile. We have pushed funding for replacement of the cool deck to 2014.

Approximately 1,735 sq ft @ \$7.50 / sq ft = **\$13,012.50**

Grinding = \$3.00/ sq ft new deck = \$3.90 / sq ft crack seal slab and expansion joint= \$0.60/ sq ft **TOTAL \$7.50/ sq ft**

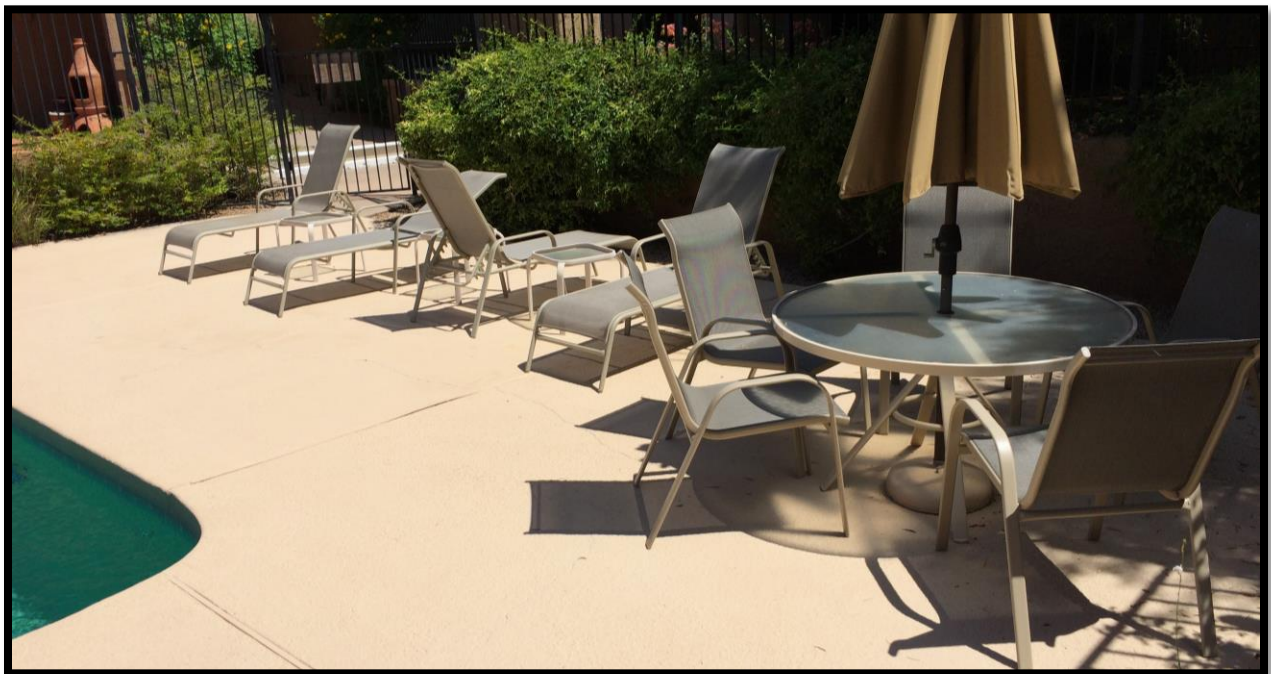
The pool furniture appears to be in good working condition at the time of the inspection. We have provided a funding plan to add and replace the furniture components every 8 years as these components are stored outside and exposed to the elements.

8 Lounge Chairs rewrapped with PVC Bands at \$100.00 each = **\$800.00**
