August 01, 2015

COMMUNITY ASSET EVALUATION

## Las Torres

Cave Creek, Arizona

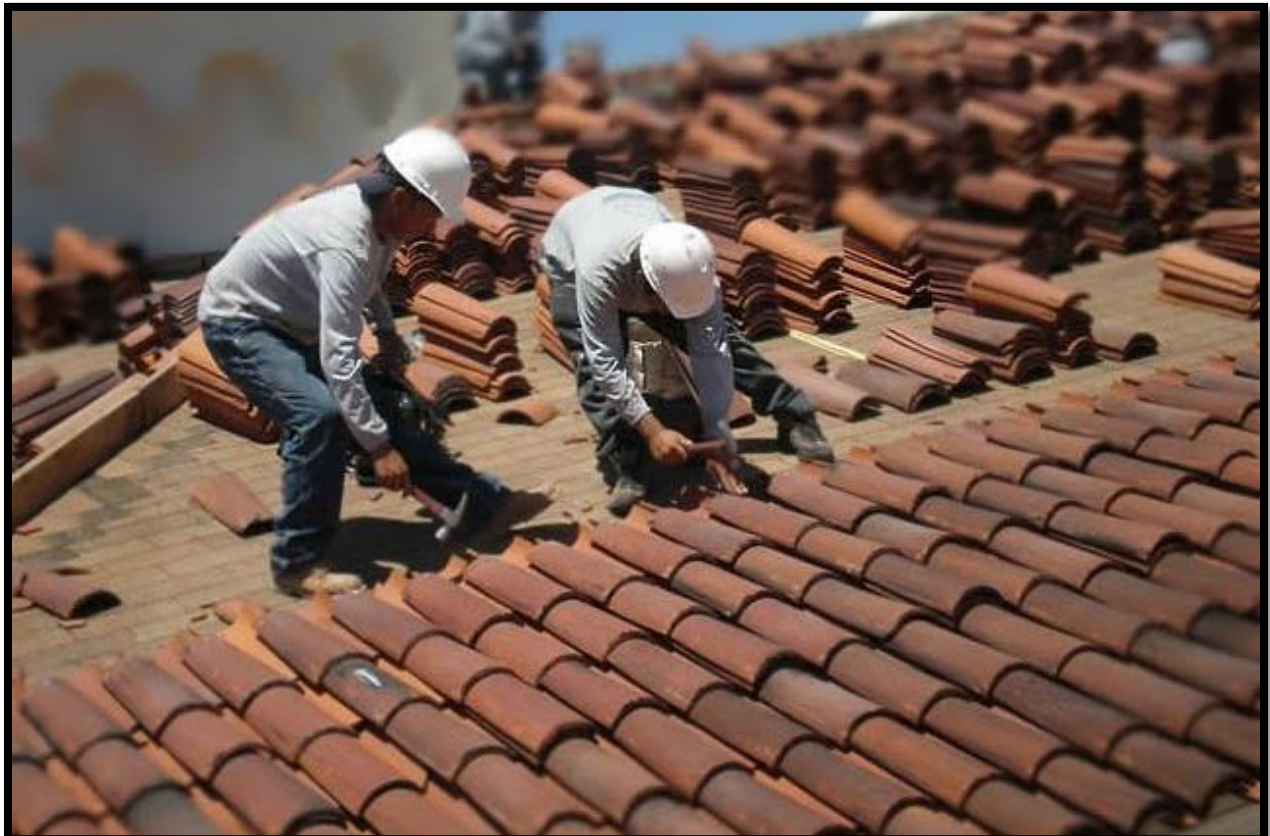
<b>Asset #400</b>	<b>Roofing Tile Underlayment</b>	<b>Quantity</b>	<b>NA</b>
Constructed	2009	Current Cost to Replace	\$183,006.00
Useful Life	20 years	Cost to Replace 2029	\$268,750.00
Years Remaining	14 years		
Replace	2029

The roofing tile underlayment was recently replaced in 2009. It consists of 2 plies of 40 lb felt mechanically attached. We have been informed that the material has a 50 year warranty combined with a contractor leak free warranty of 10 years. We strongly recommend the Association read and fully understand the details of this warranty as adhere to all required maintenance and inspection stipulations per the warranty. If there are no requirements we recommend hiring a licensed and bonded roofing professional to inspect the roof surfaces at a minimum on occurrence per year. Please read the roofing report provided by Roofing Southwest. This report has effected the reserve study significantly as the previous report did not fund for underlayment replacement at the direction of the BOD at that time.

Approximately 49,461 square feet removed and replaced at \$3.70 each = **\$183,005.70**
