June 3, 2020

PROPERTY: LAS TORRES HOMEOWNERS ASSOCIATION  
CAREFREE, ARIZONA

SERVICE: FULL PROPERTY EVALUATION AND RESERVE FUND ANALYSIS

ATTACHMENT: 19-0228 FINAL REPORT – REVISION 1

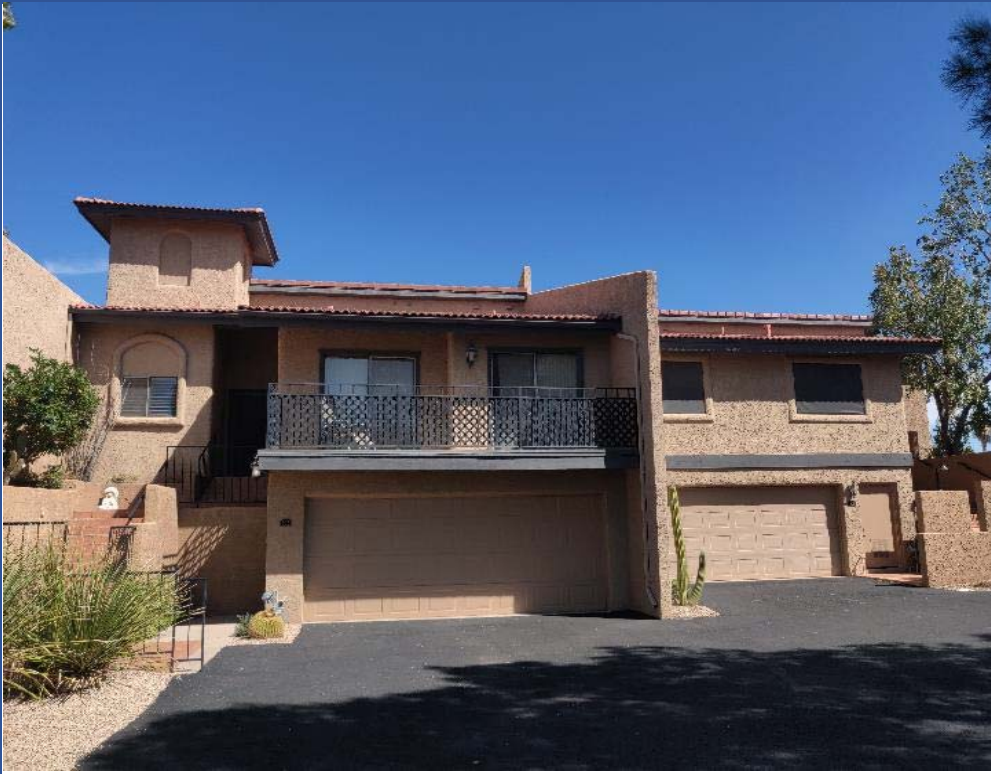
1

Las Torres community

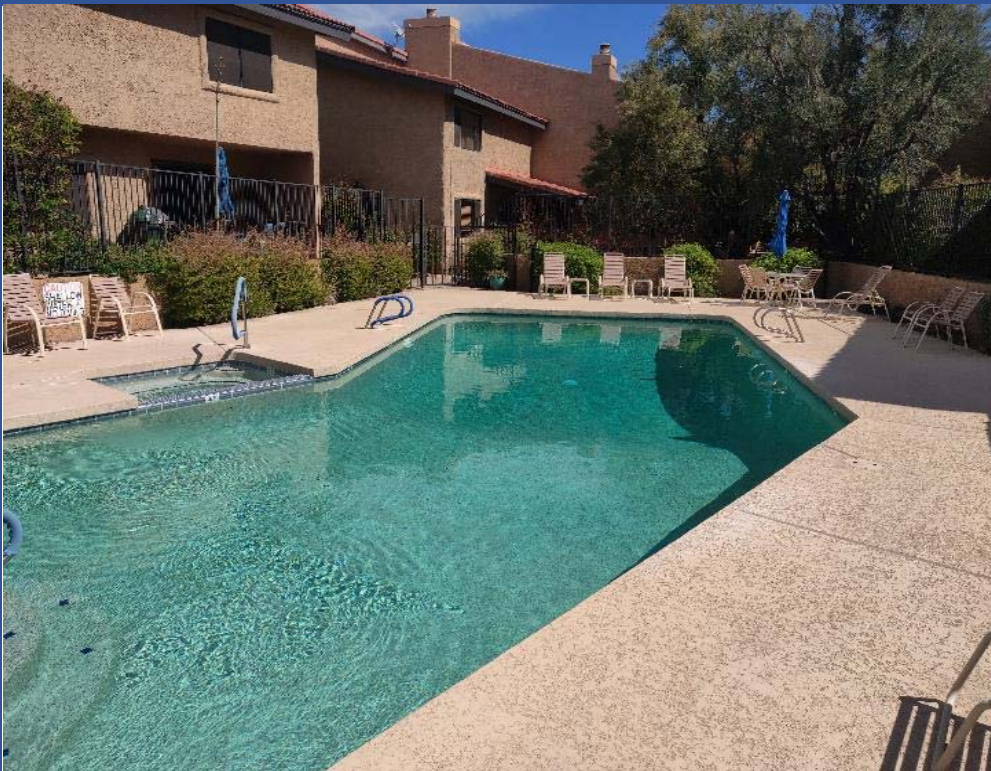
2

Community pool  
overview

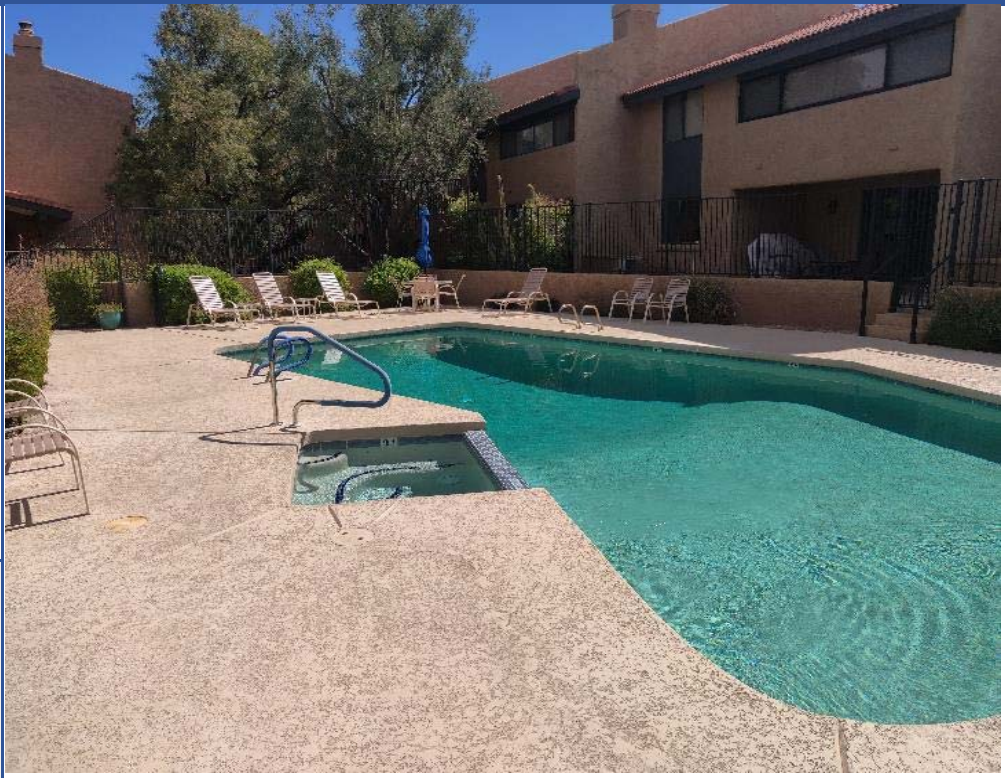
**3**

Community pool and spa overview

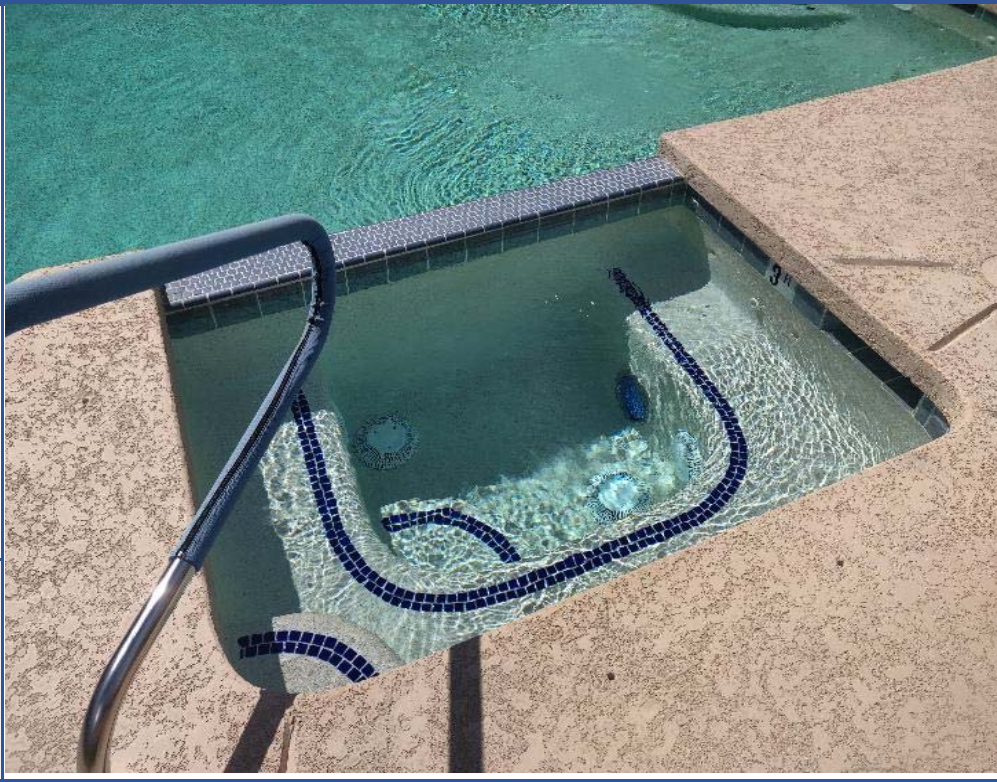
PHOTO NUMBER  
**5**

Spa - recently retiled and brought up to code

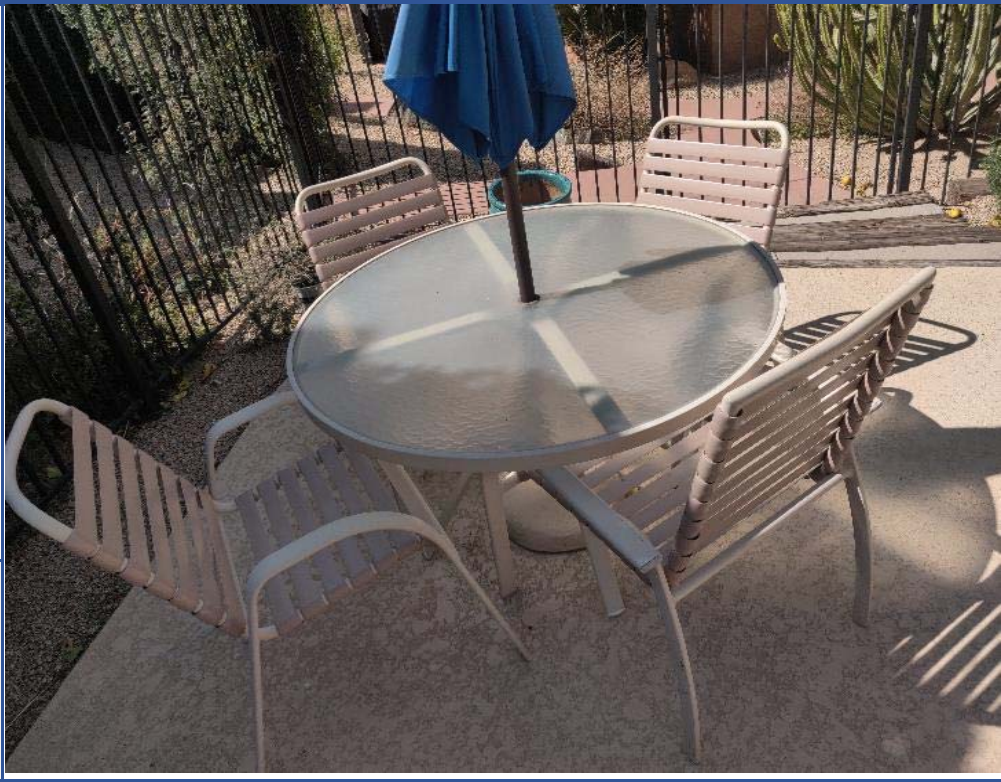
8

Typical table and chairs with central umbrella

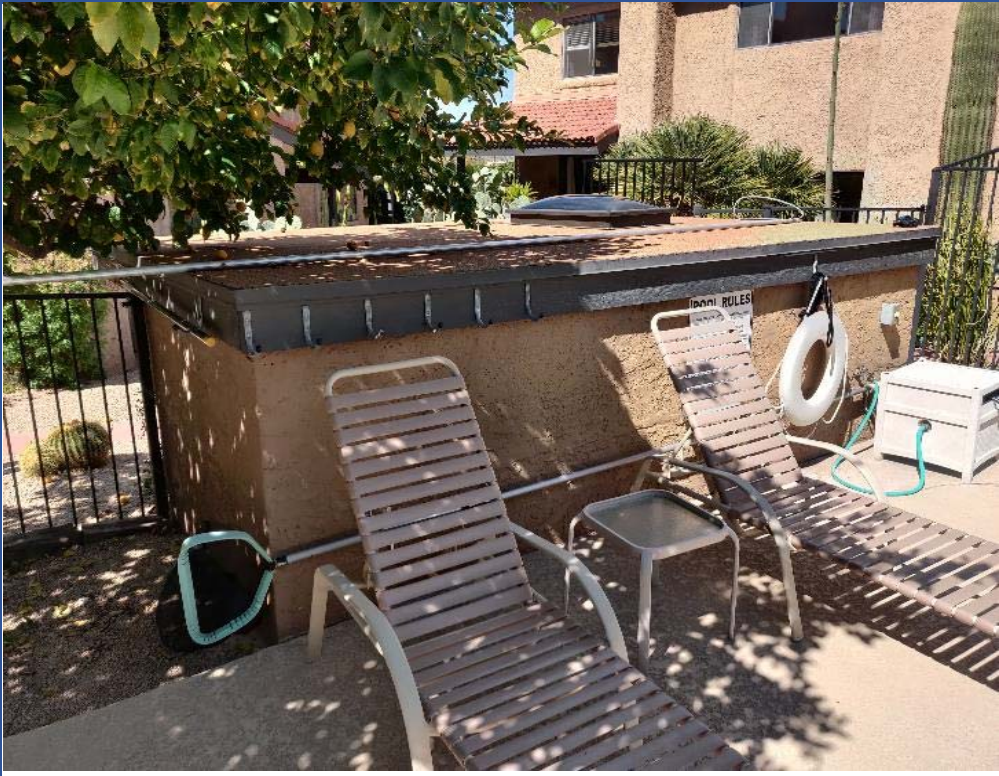
The pool equipment room was in generally fair to good condition.

Pool pump room

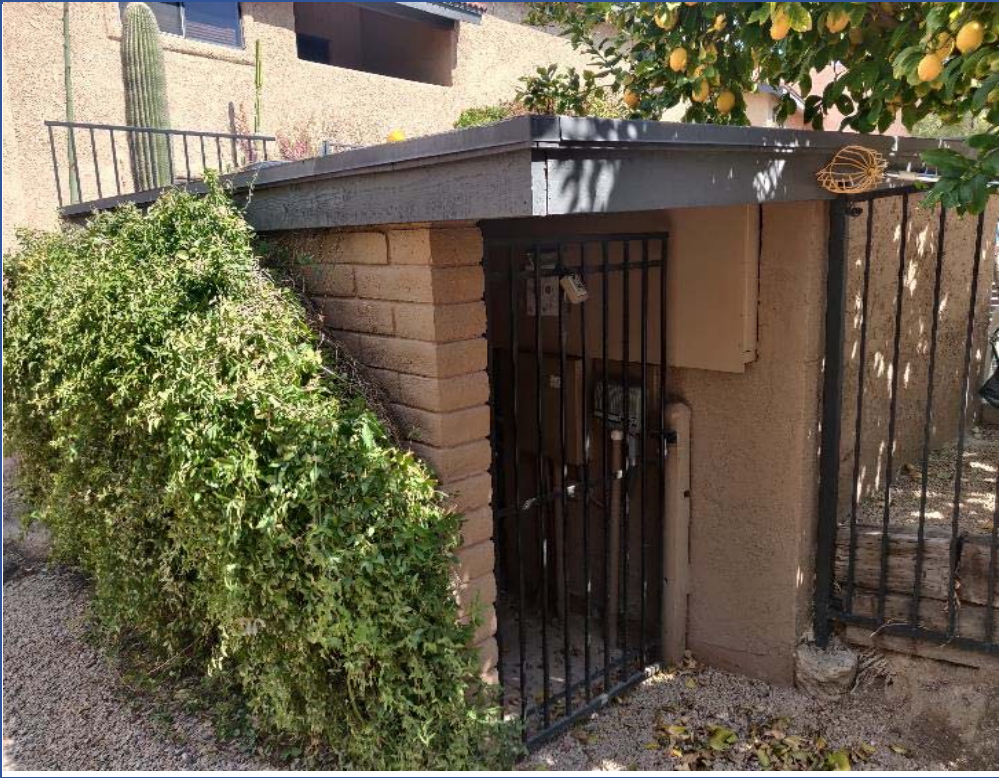
14

Pool equipment house

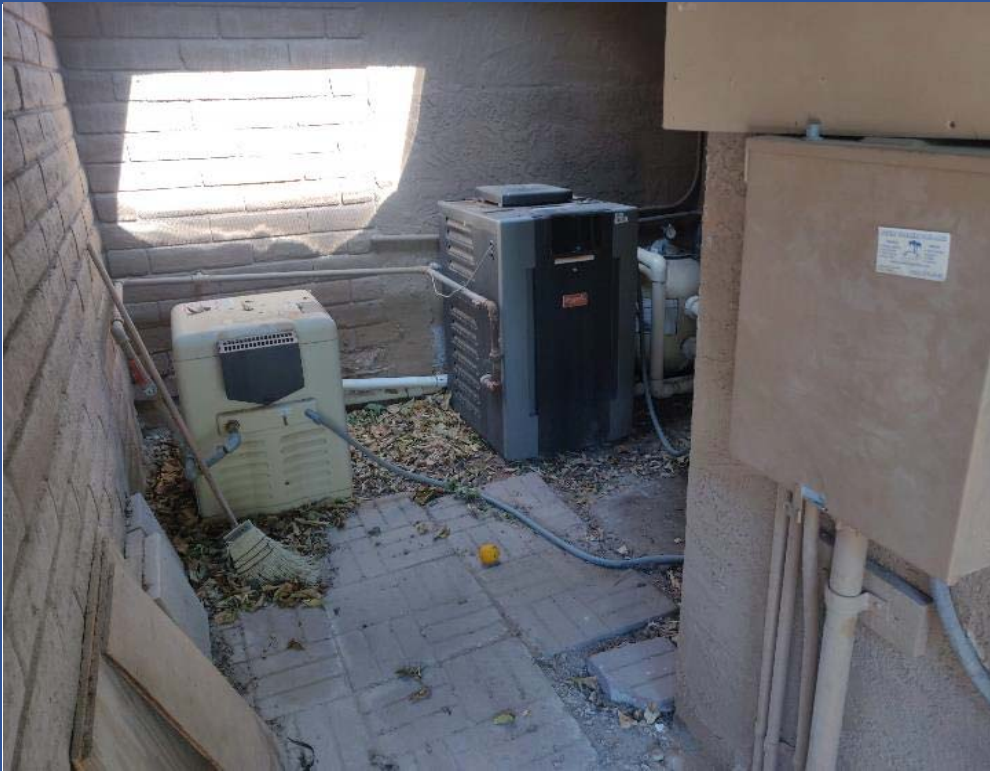
15

Pool and spa heaters

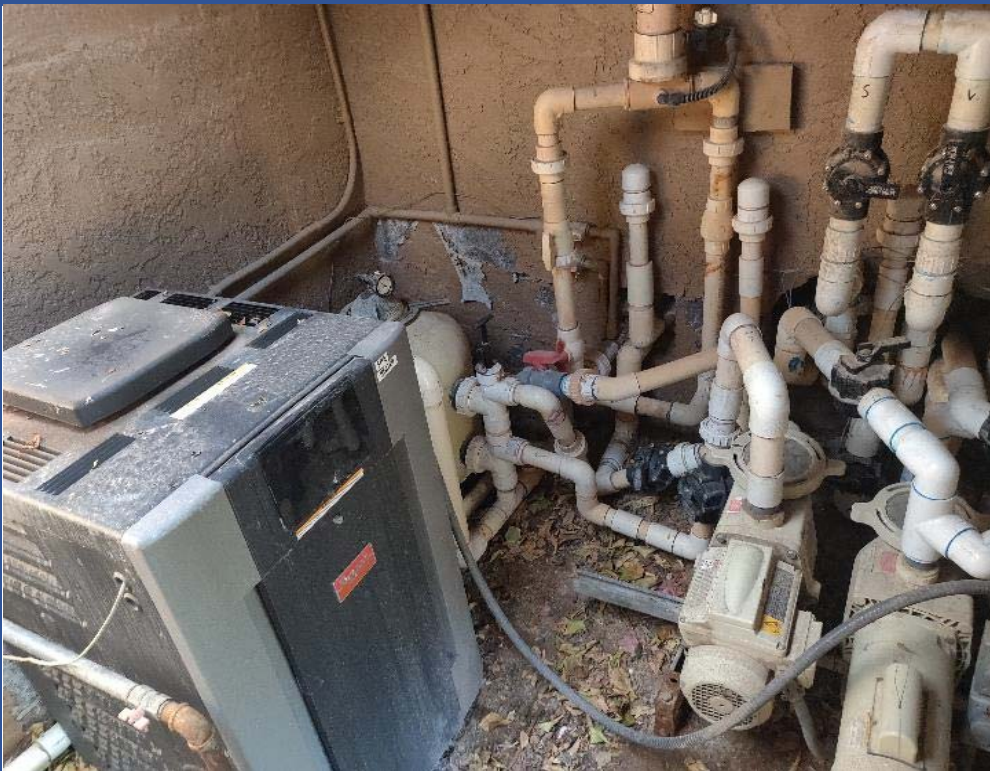
16

Pool pumps

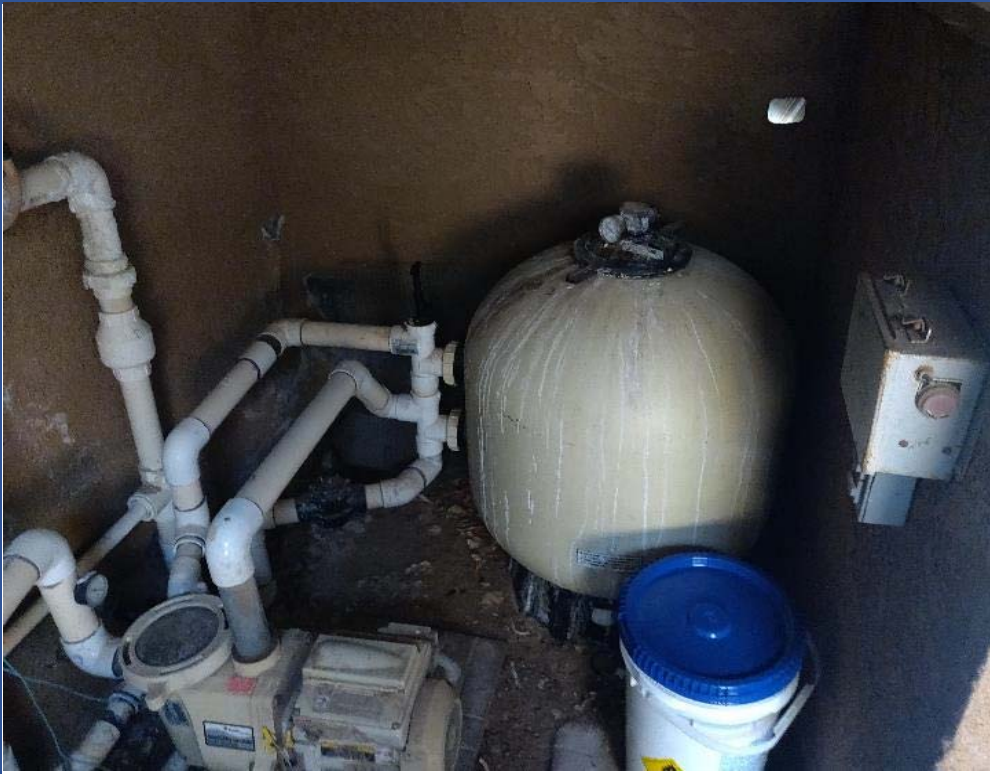
17

Pentair Triton II TR140  
sand filter for the pool

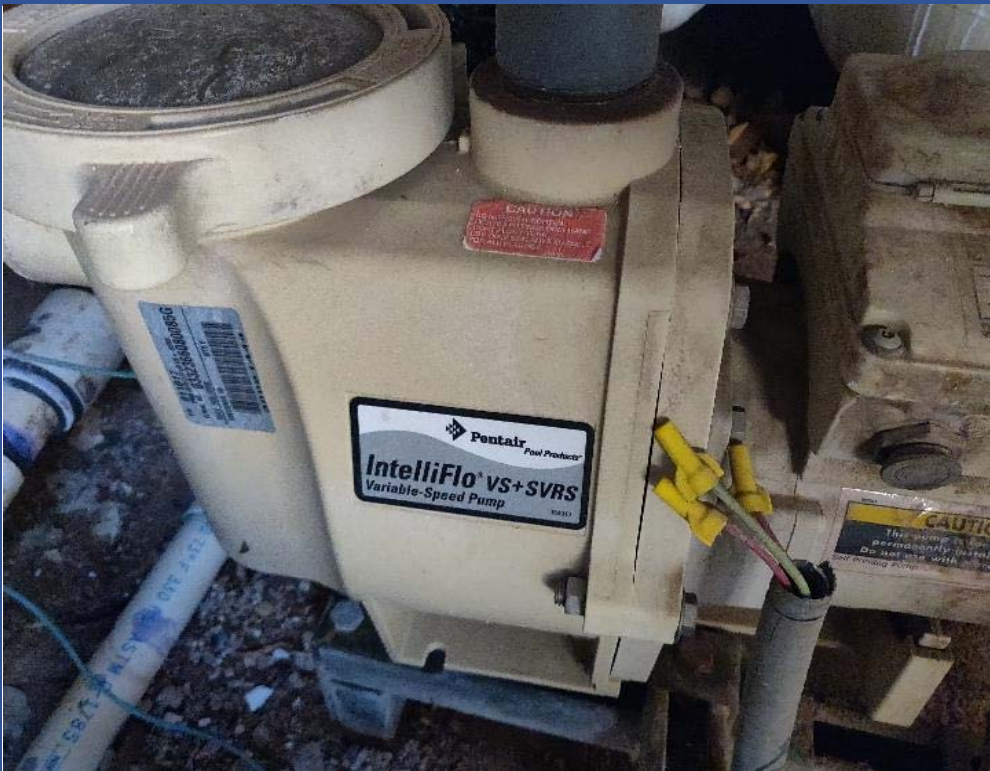
18

Pentair IntelliFlo  
VS+SVRS 3 HP pump

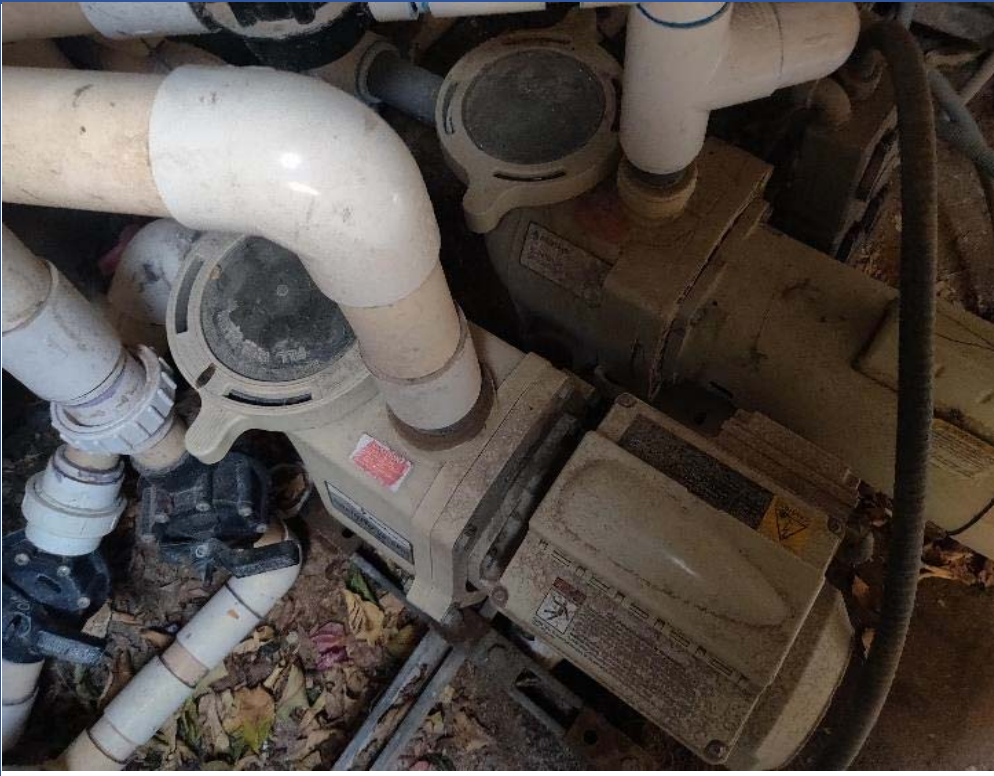
Pool pumps

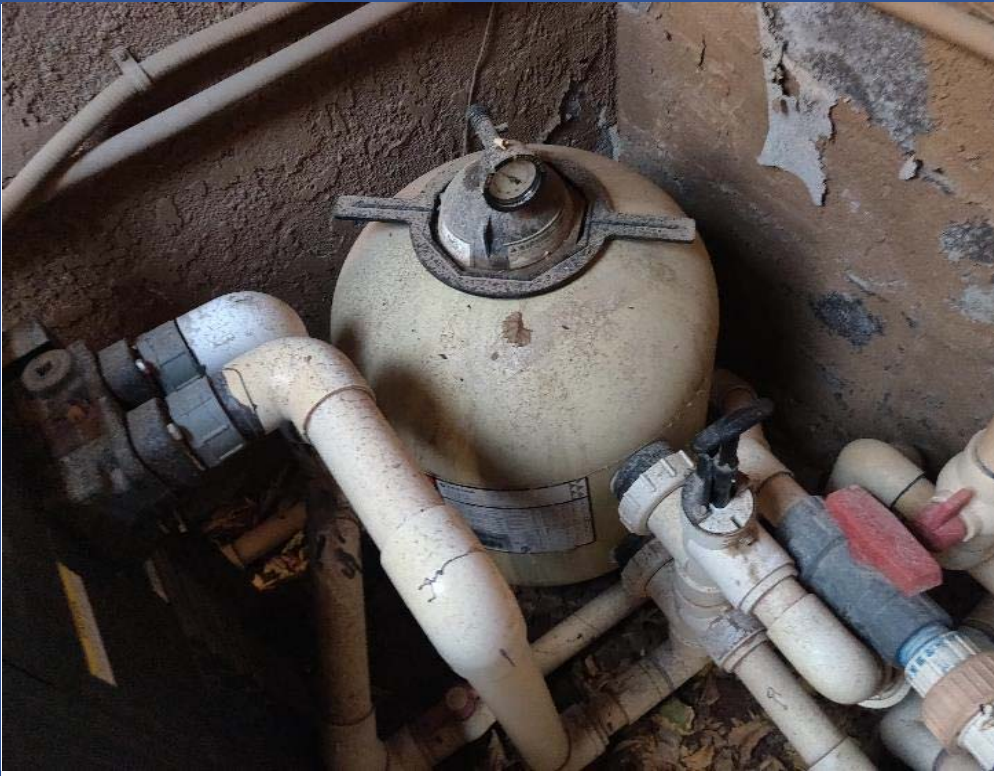
Pentair Triton - II TR40  
sand filter for the spa

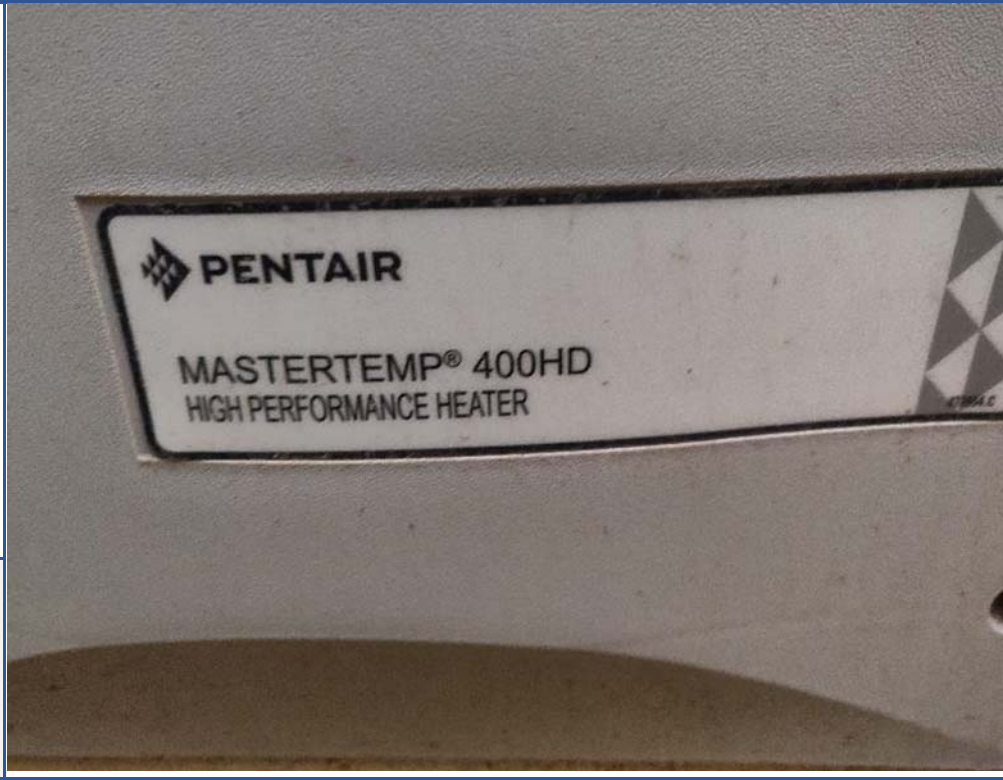
22

Pentair MasterTemp 400 pool heater

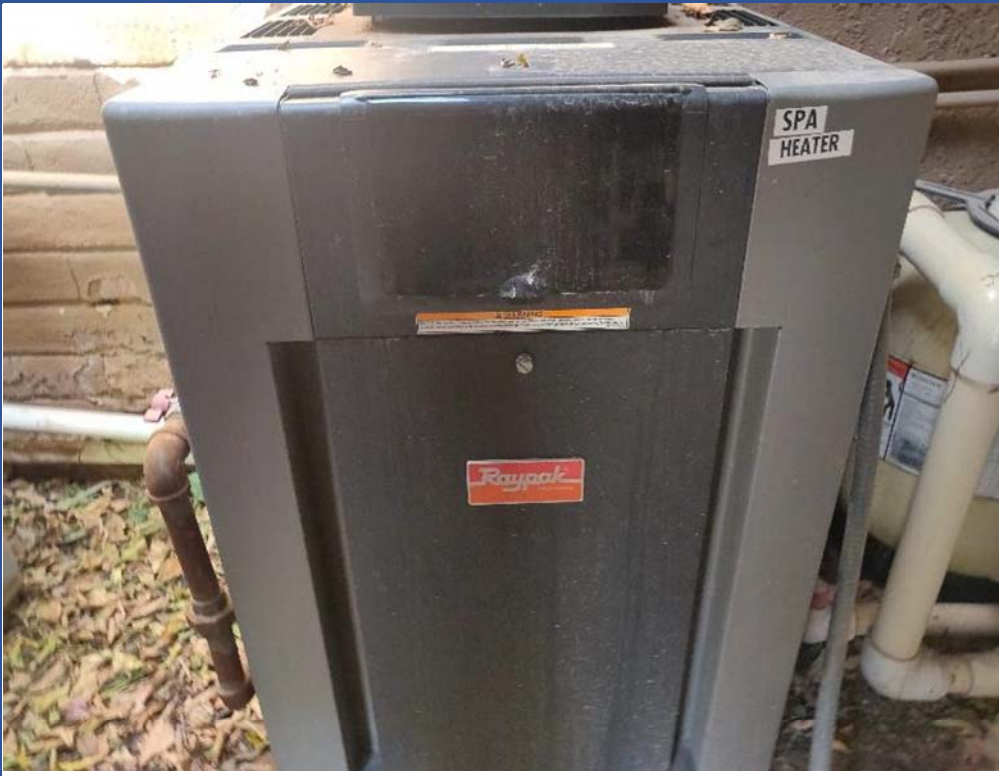
Raypak 266k BTU Spa heater

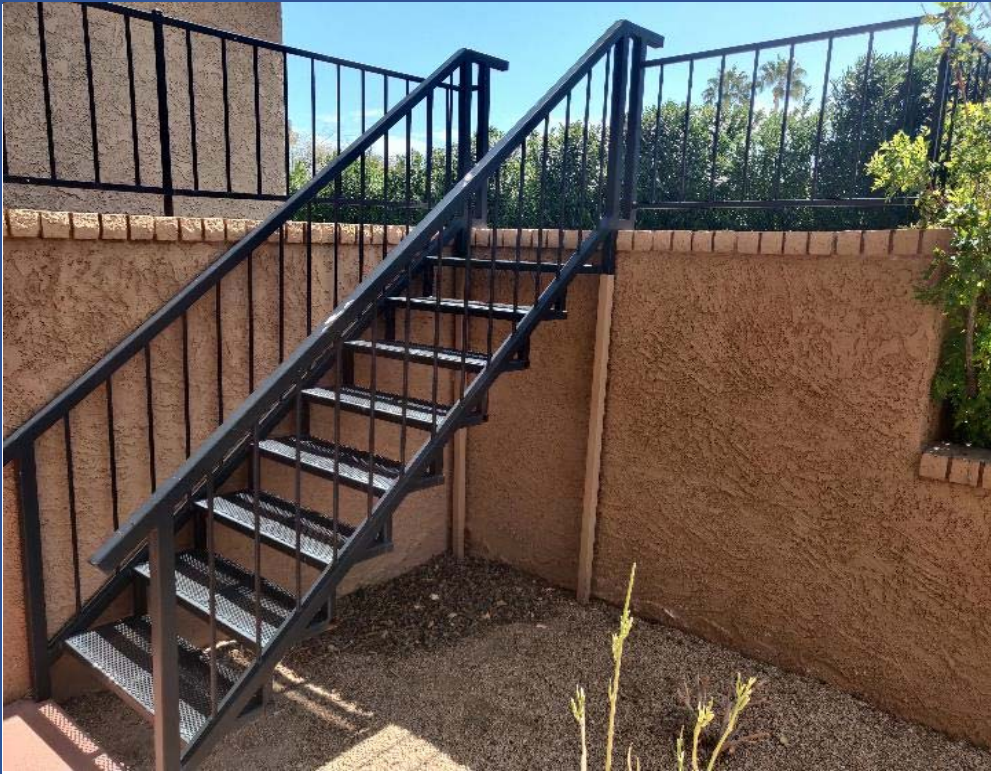
25

Exterior metal staircase -  
Retaining wall has no  
visible weep holes

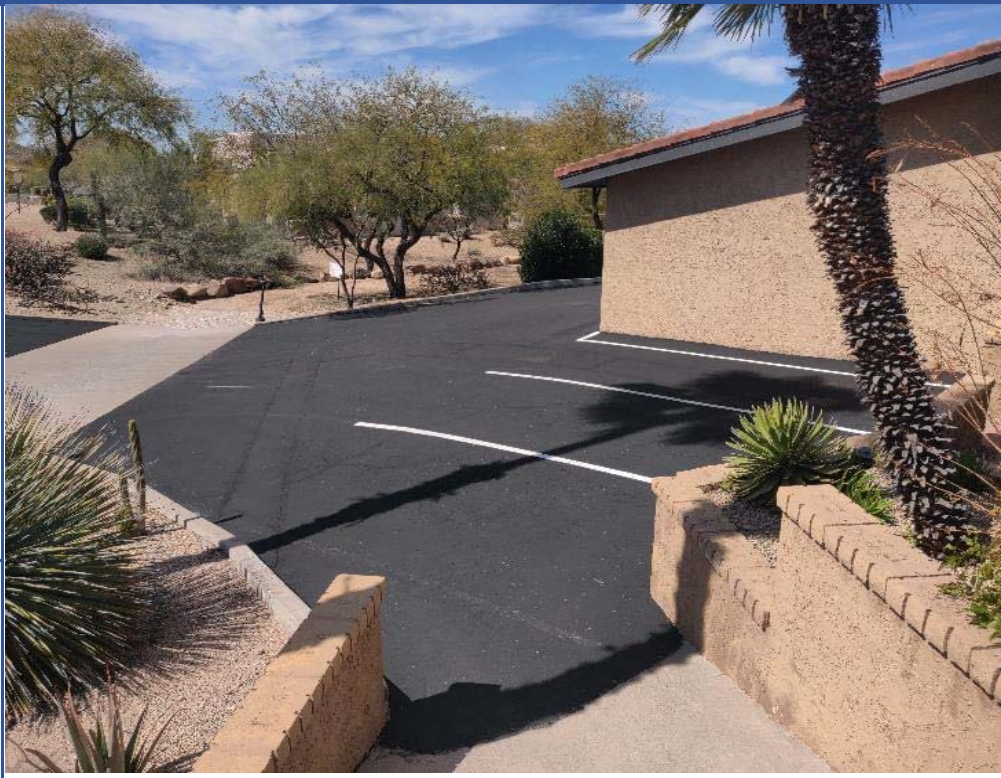
The asphalt-paved entrances and parking spaces near the sports court and throughout the community are in generally good to fair condition with some deficiencies noted.

Parking area overview

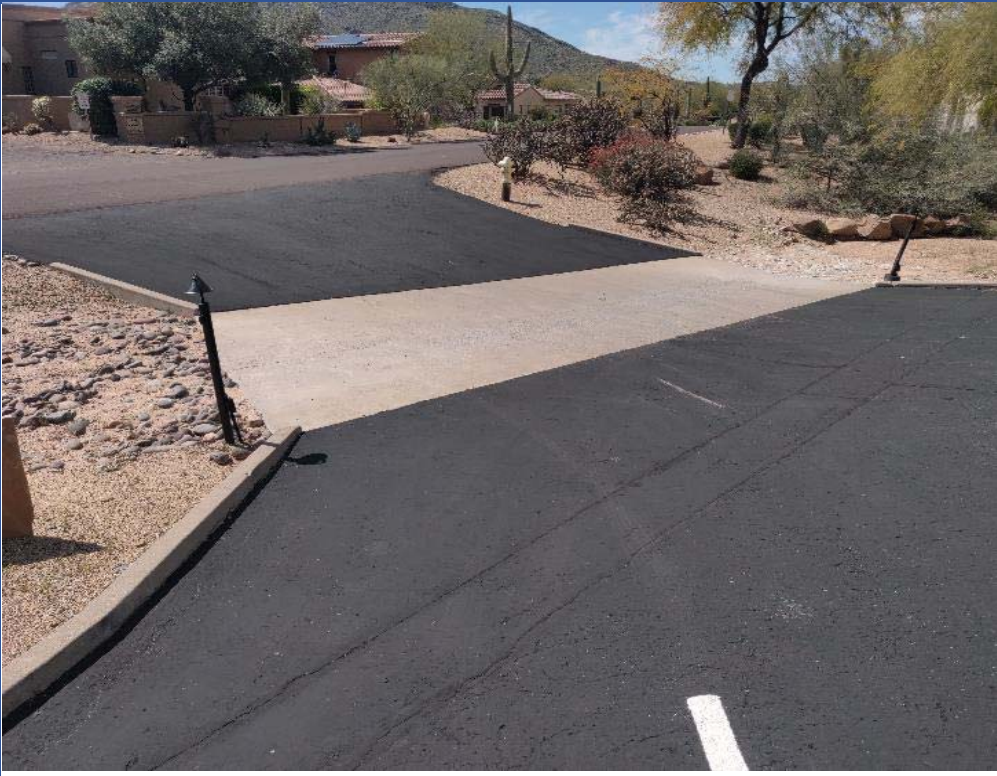
31

Concrete flowline

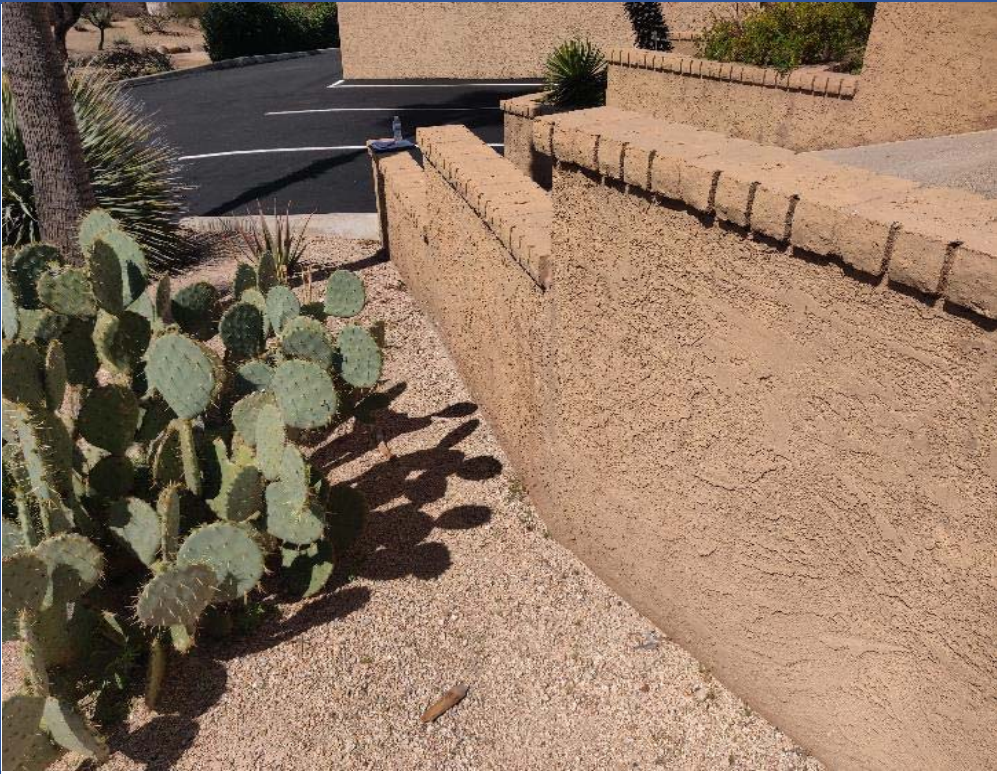
32

Perimeter wall is retaining and contains no weep holes

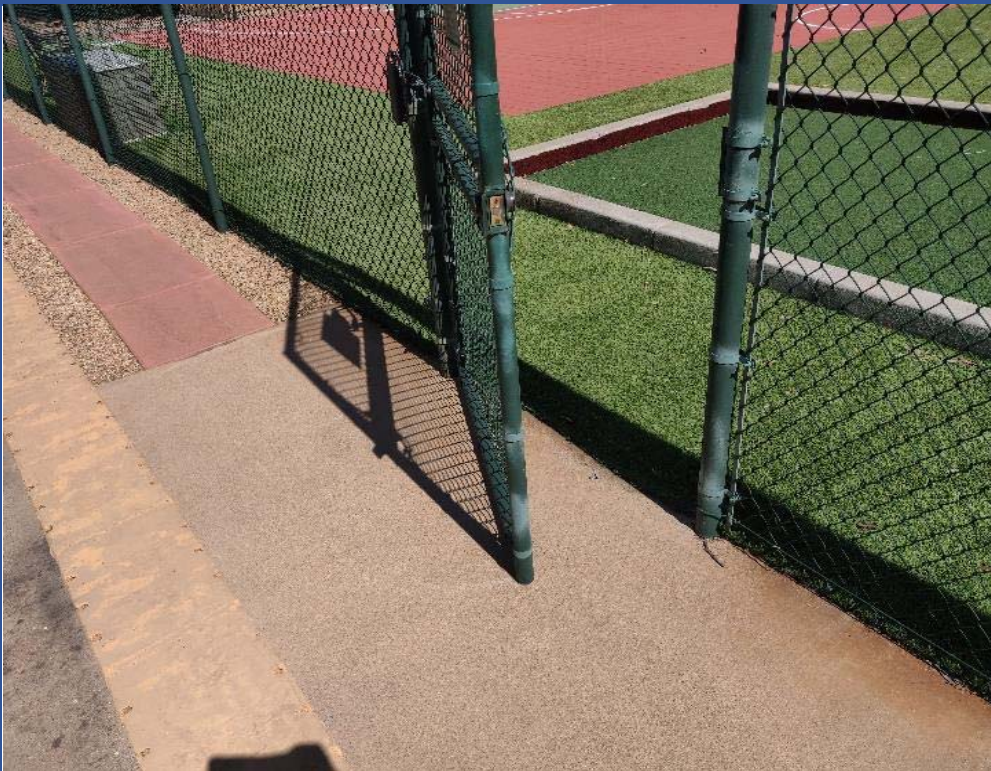
44

Entrance gate to the sports court scrapes the ground at this point and does not freely open wider than pictured

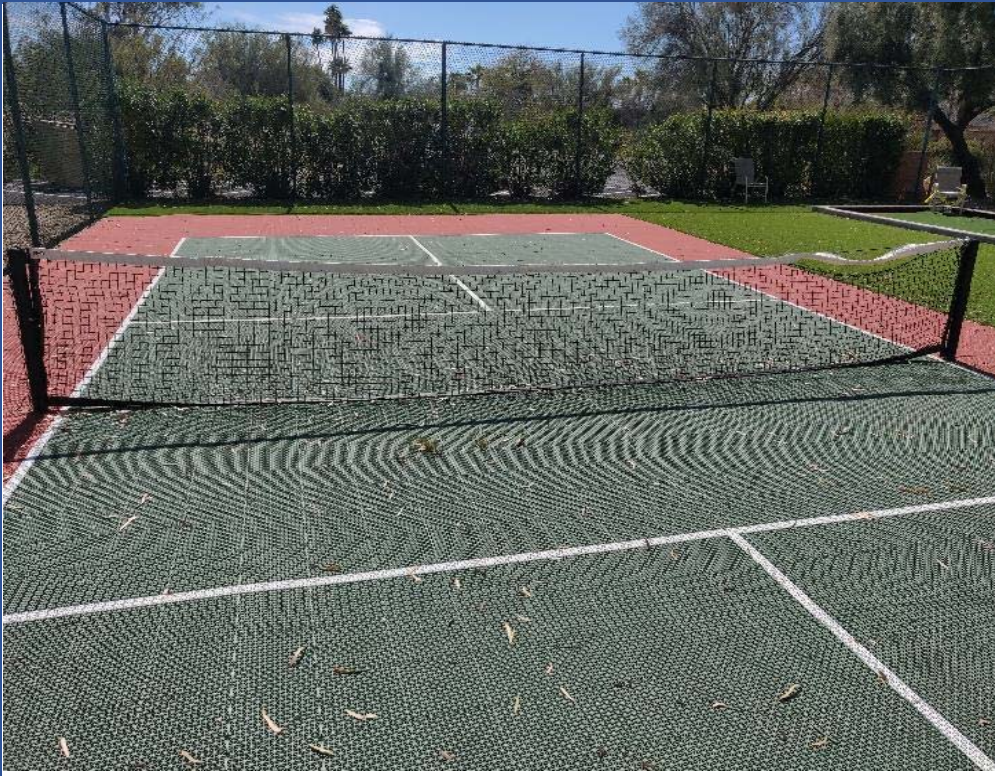
**49**

Tennis court - net ripped

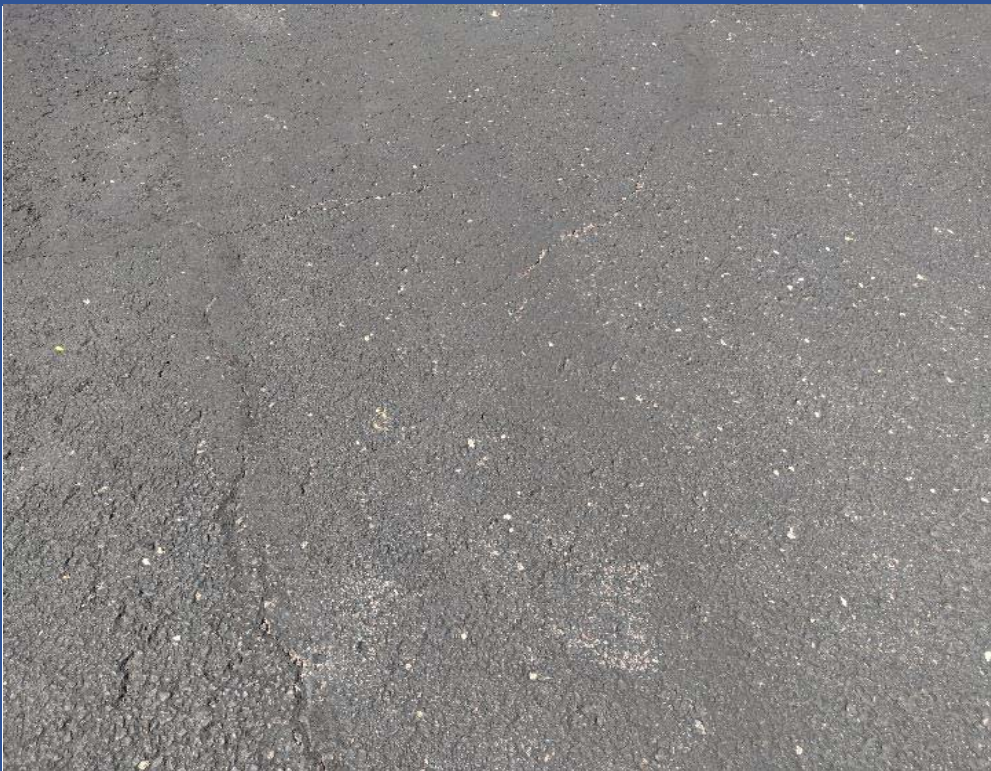
Asphalt beginning loss of aggregate

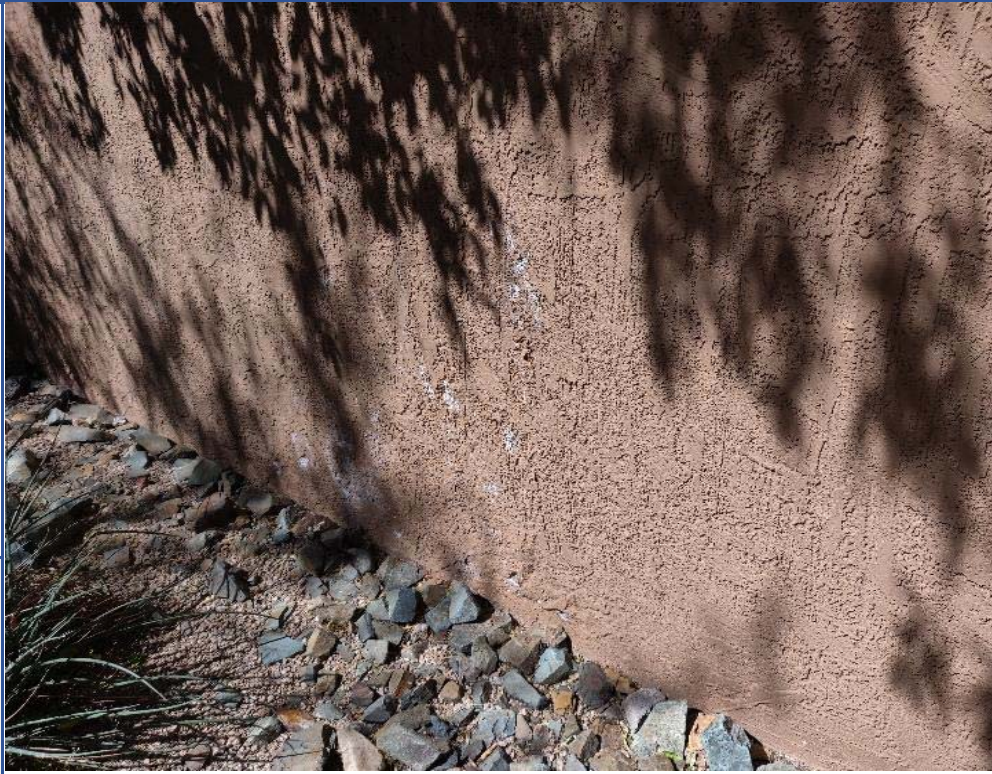
67

Retaining wall with visible efflorescence

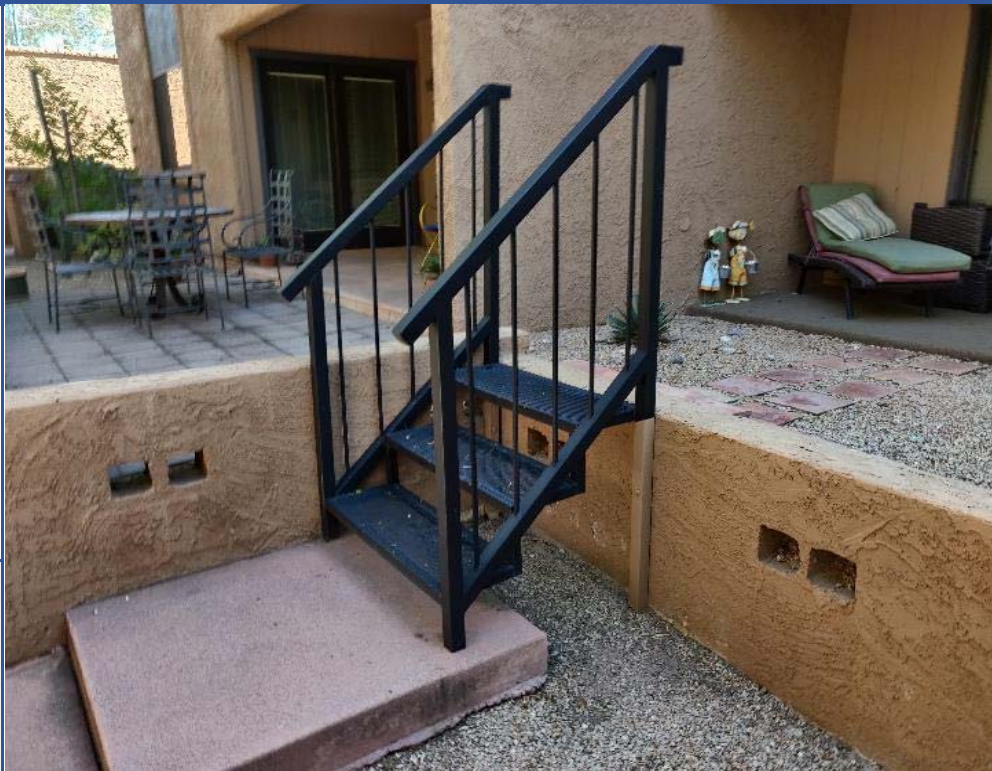
68

Small wrought iron staircase - retaining walls with no visible weep holes

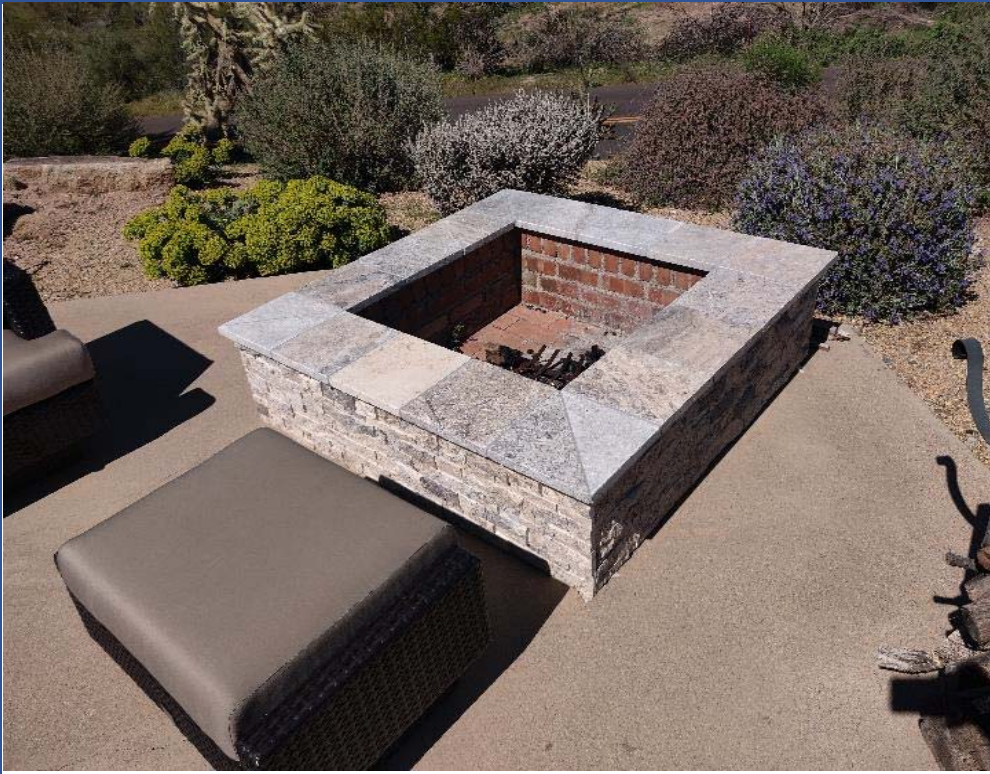
77

Firepit recently retiled

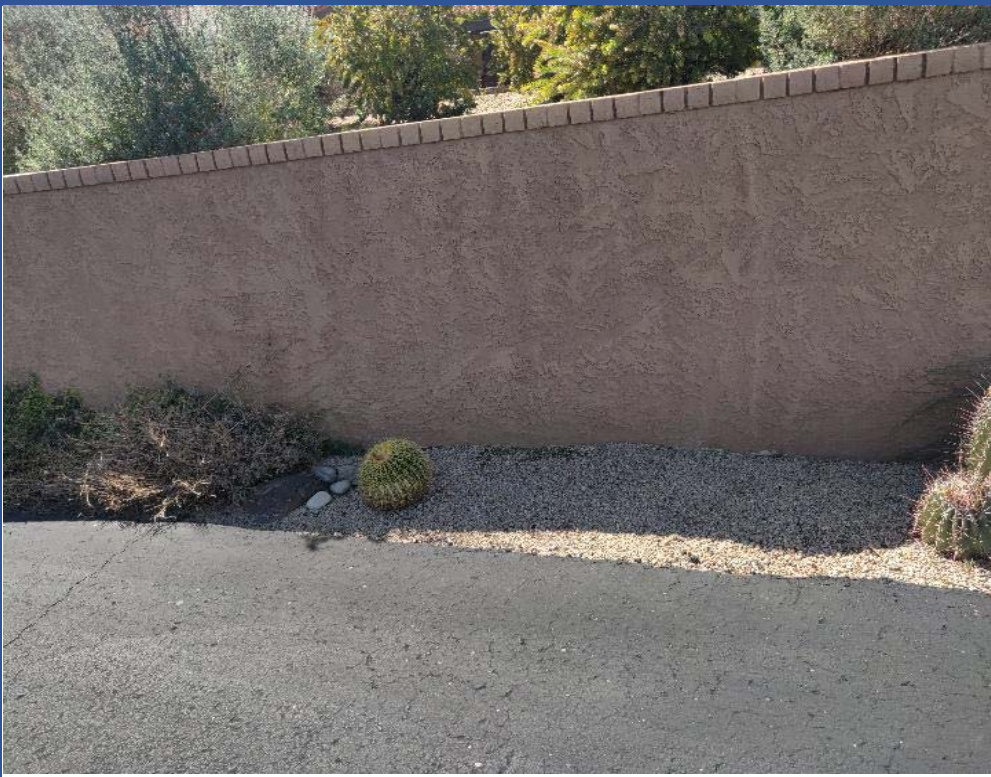
81

Retaining wall with no visible weep holes
